PRESERVATION ASSESSMENT OF TOLSON'S CHAPEL CEMETERY, SHARPSBURG, MARYLAND

Chicora Research Contribution 552

Prepared By:
Michael Trinkley, Ph.D.
and
Debi Hacker

May 1, 2013

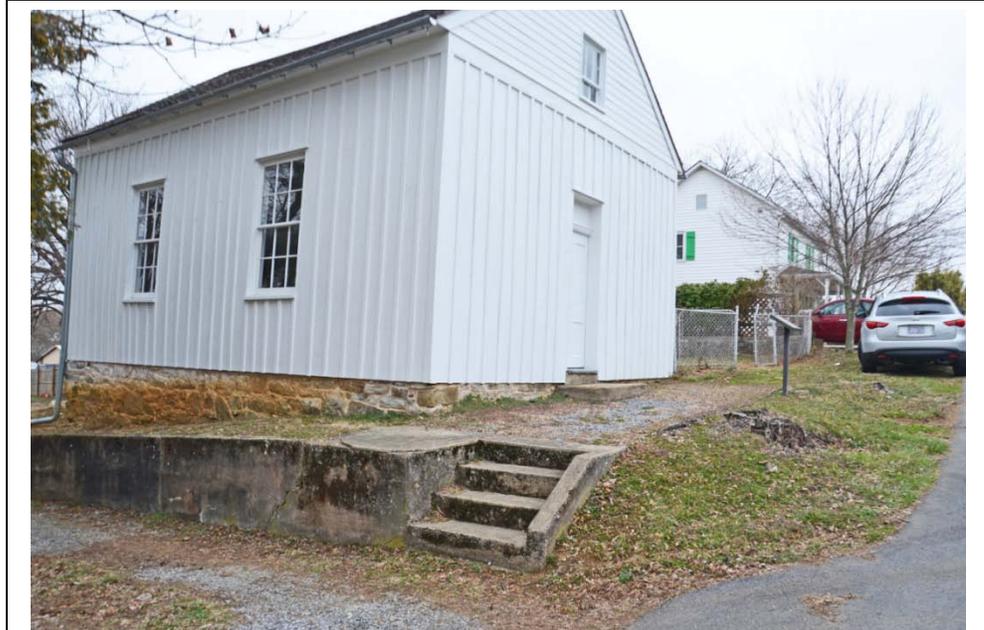
Figure 18. Steps and graveled walkway in front of Tolson's Chapel. Note also the limited parking area. The entrance gates are to the left of the parked automobile. View is to the northeast.

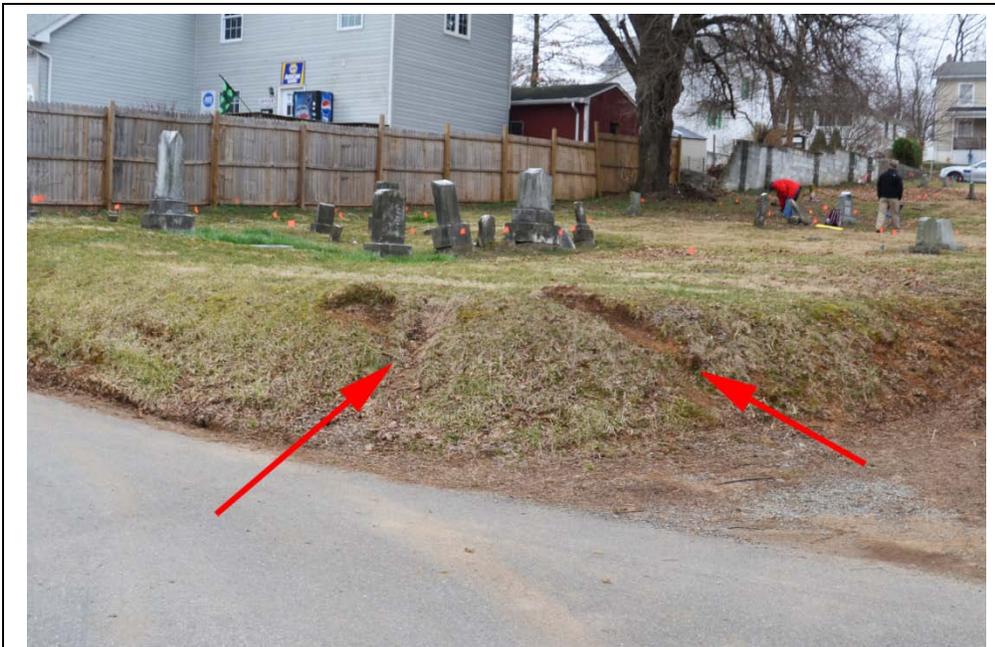
Figure 21. Rear of cemetery showing erosional areas caused by using the slope as a bike ramp. View is looking to the southeast.

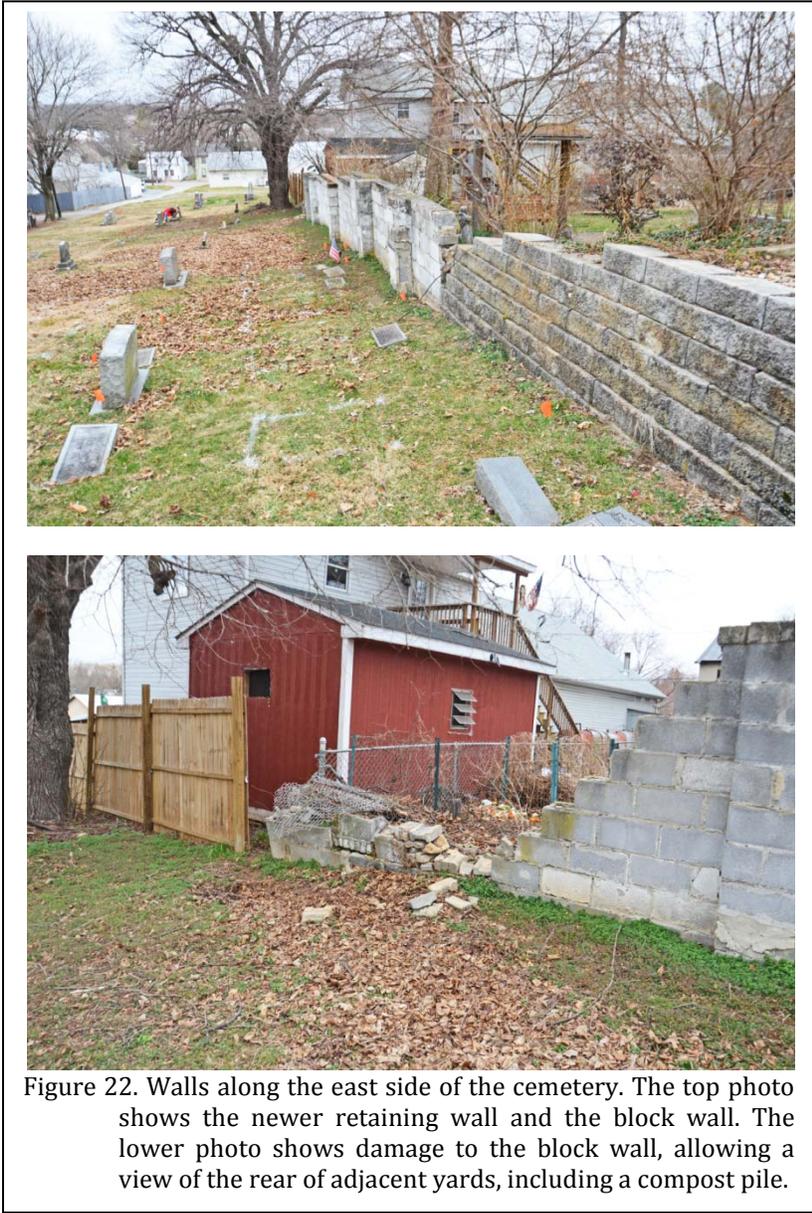
Figure 22. Walls along the east side of the cemetery. The top photo shows the newer retaining wall and the block wall. The lower photo shows damage to the block wall, allowing a view of the rear of adjacent yards, including a compost pile.

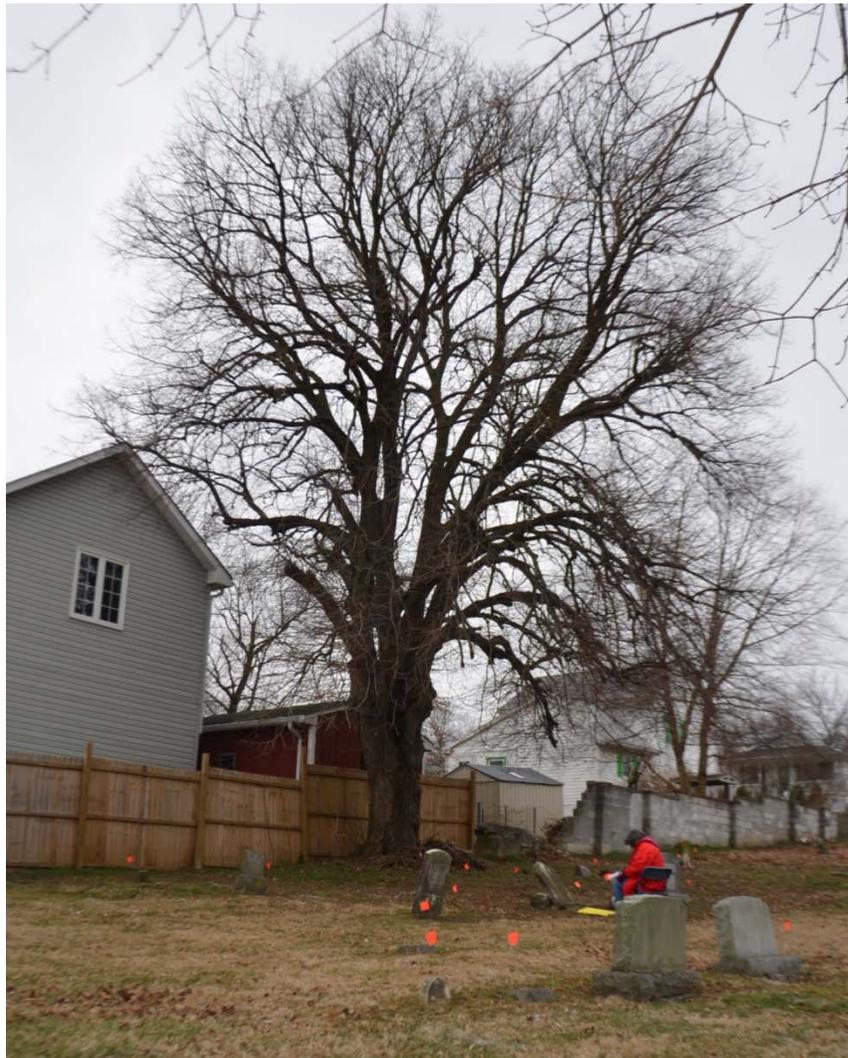
Figure 24. Maple along the east edge of the cemetery. Note damaged branches, crossed branches, and the need for pruning by a certified arborist.

The single tree on site requires pruning

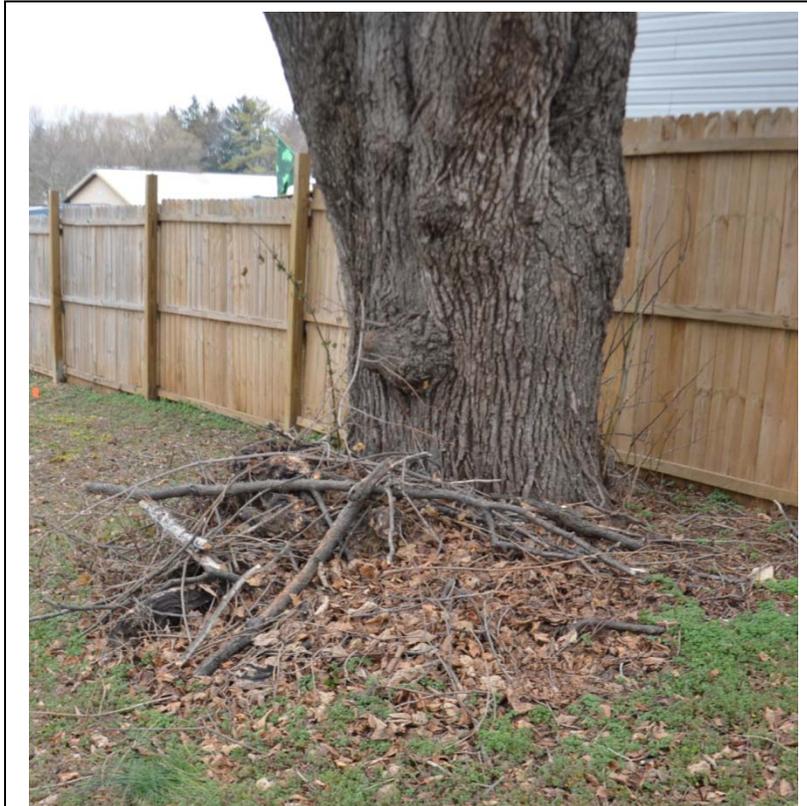
Figure 25. Branches and limbs stacked at the base of the maple should be immediately removed. Picking up and disposing of downed branches should be part of every mowing.

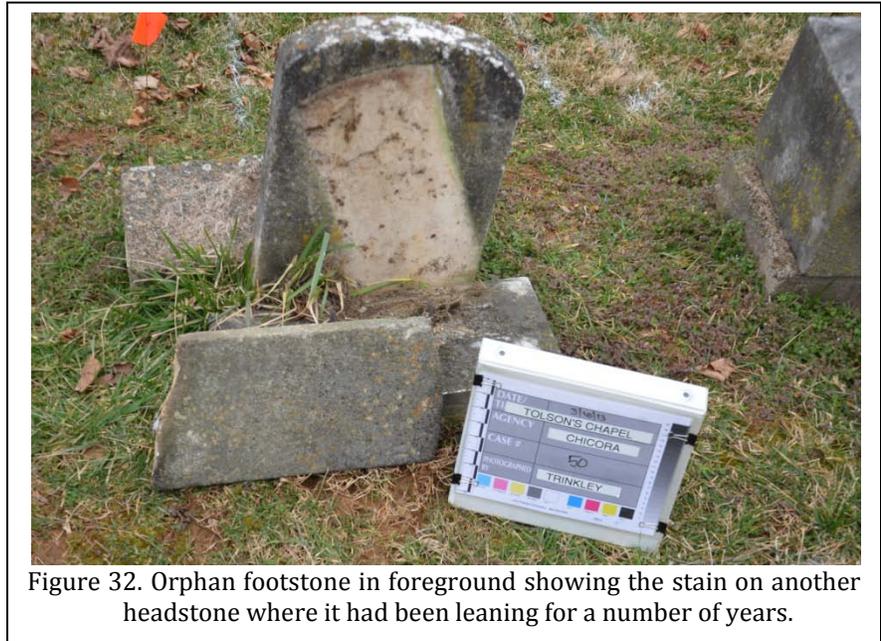
Figure 32. Orphan footstone in foreground showing the stain on another headstone where it had been leaning for a number of years.

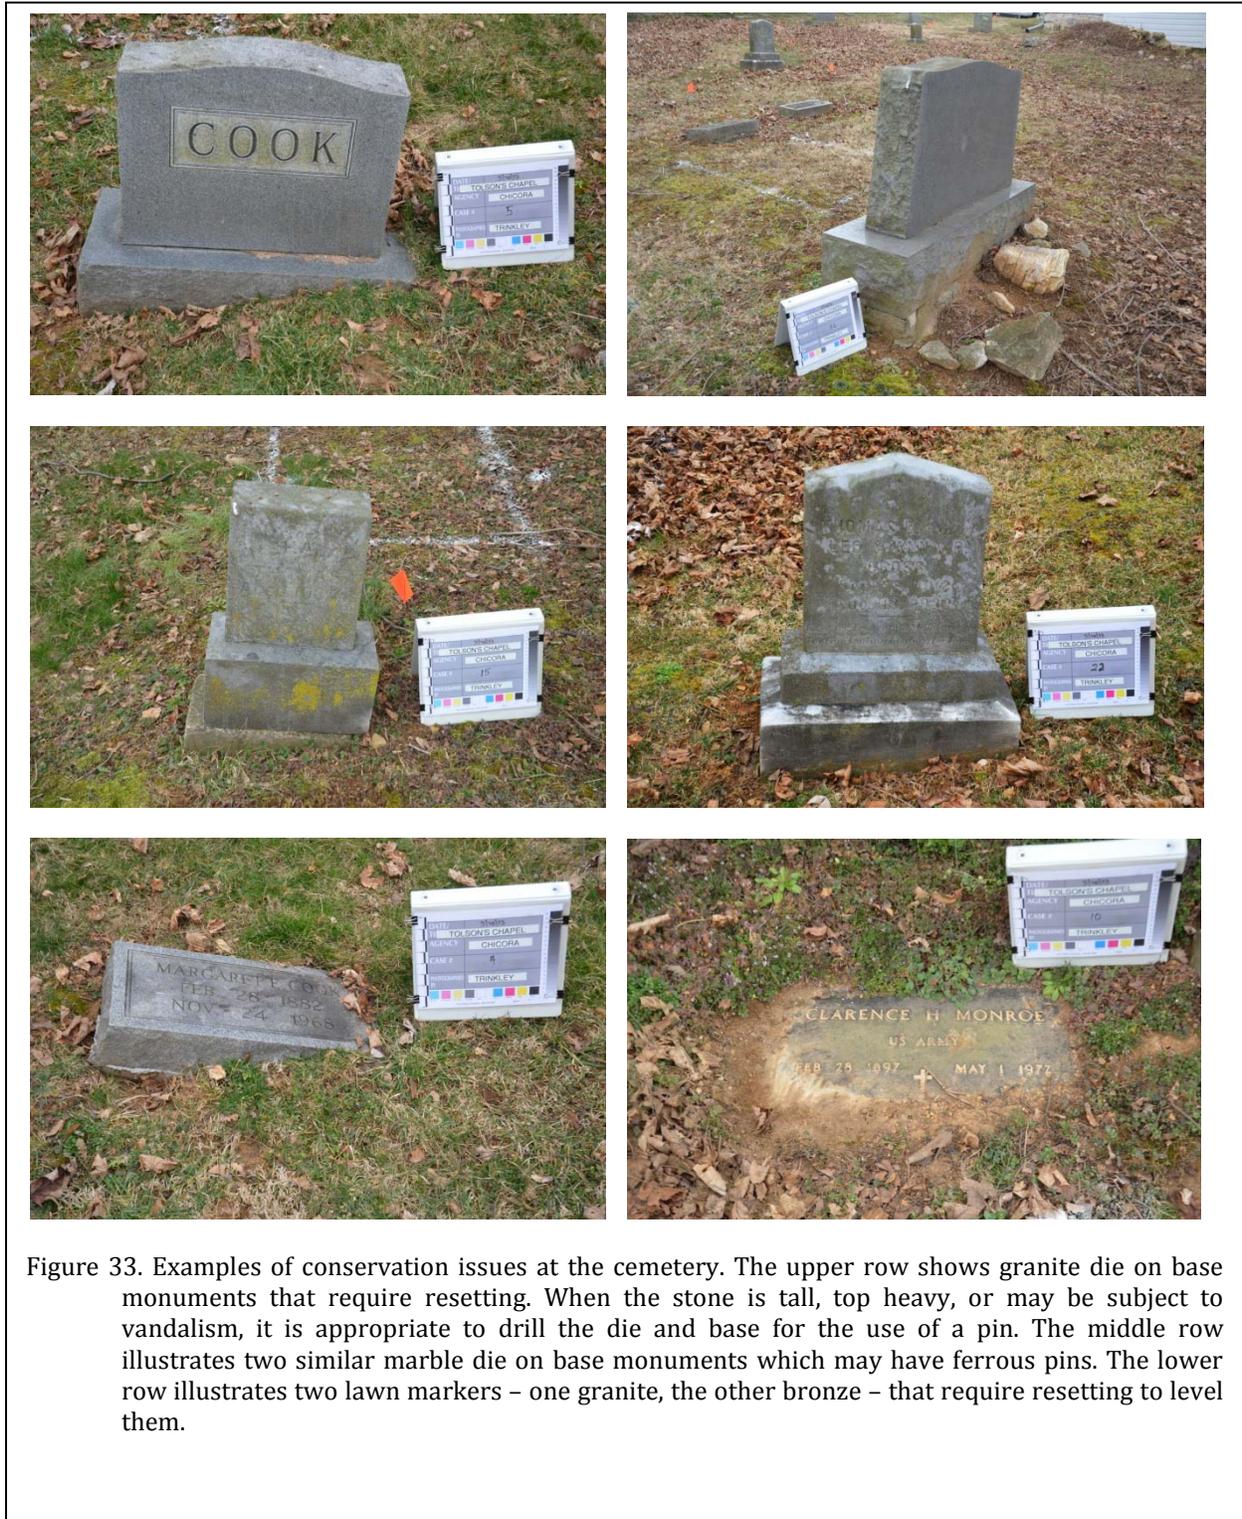
Figure 33. Examples of conservation issues at the cemetery. The upper row shows granite die on base monuments that require resetting. When the stone is tall, top heavy, or may be subject to vandalism, it is appropriate to drill the die and base for the use of a pin. The middle row illustrates two similar marble die on base monuments which may have ferrous pins. The lower row illustrates two lawn markers – one granite, the other bronze – that require resetting to level them.

The stone should be excavated, being careful to avoid shovel damage. There are some lawn markers that have been set in concrete and the removal of this material may require a conservator to ensure that the stone itself isn’t damaged. Otherwise, the hole can be deepened

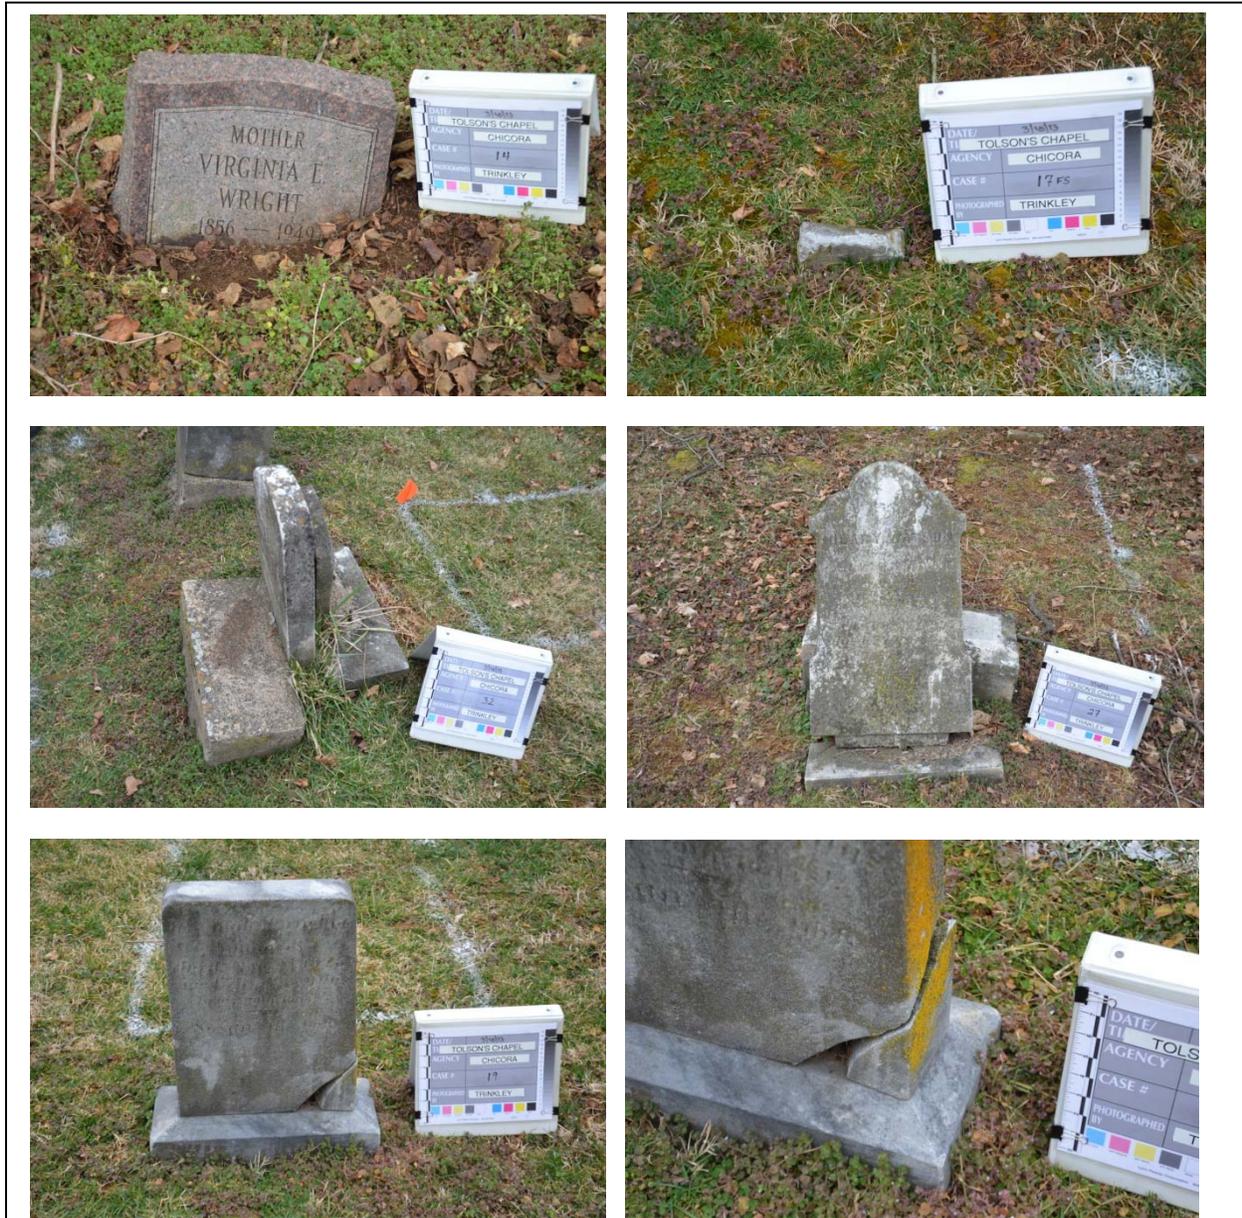
Some die on base stones were observed that had been set using ferrous pins to join the die and base. These stones should be given a high treatment priority since, left untreated, the corrosion of the ferrous pin will cause significant spalling, cracking, and breakage of the stones – a process known as “iron jacking.” The corrosion products of these ferrous pins have a greater volume than the original pin and as the corrosion products expand, they crack the stone.

Figure 34. Examples of conservation issues at the cemetery. The upper row shows a granite plaque stone on the left and a marble footstone on the right that require resetting to level and ensure they are at the correct height. The middle row left stone is broken and requires drilling and pinning. The middle row right stone is a marble tab in socket that simply requires resetting using a lime-based mortar. The bottom row shows a stone where the ferrous pin has caused iron jacking, spalling off the marble corner. Such stones require that the ferrous pin(s) be drilled out and replaced with a fiberglass or 316 stainless steel pin.
