PRESERVATION ASSESSMENT OF TOLSON'S CHAPEL CEMETERY, SHARPSBURG, MARYLAND

Chicora Research Contribution 552

Prepared By:
Michael Trinkley, Ph.D.
and
Debi Hacker

May 1, 2013

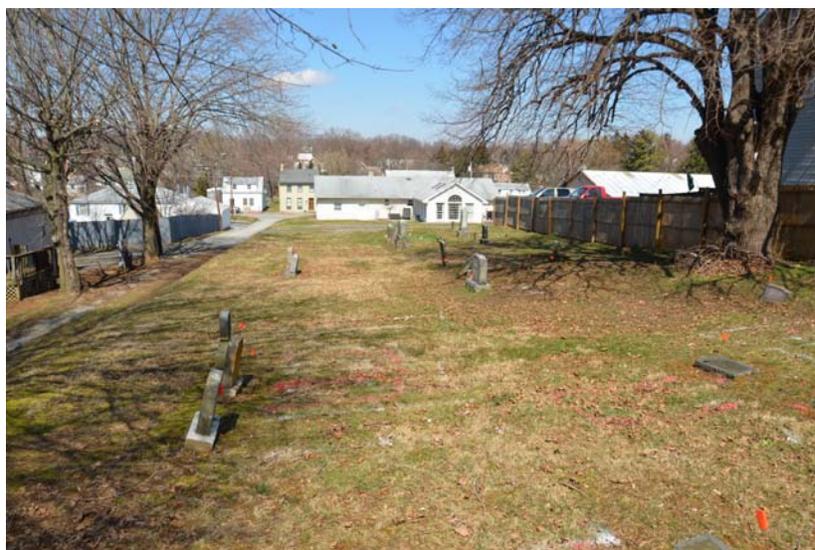
Figure 3. Tolson's Chapel cemetery from the chapel looking north.

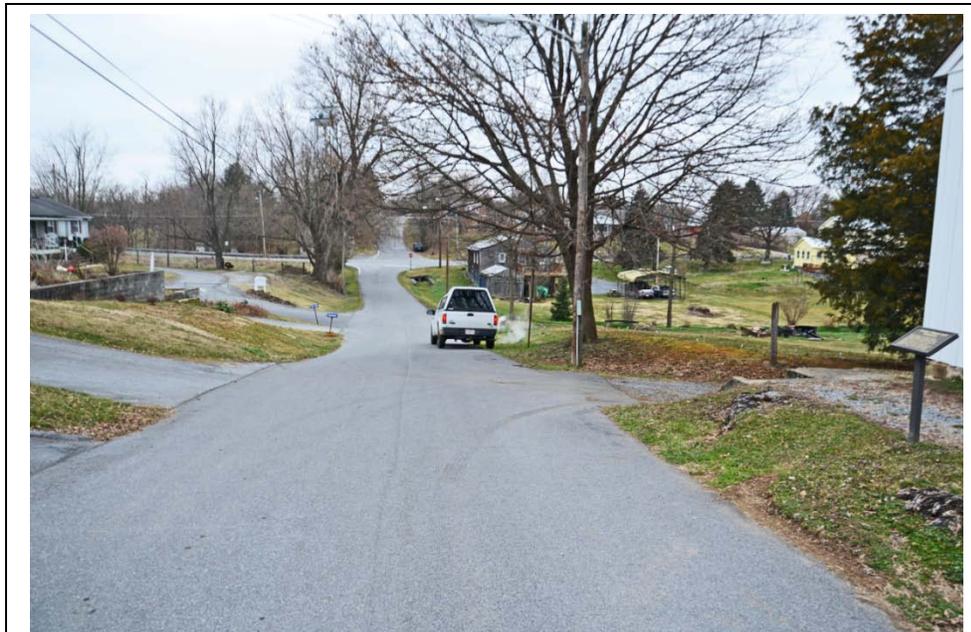
The entrance to the churchyard incorporates a double gate, allowing about 8 feet of clearance. This does allow vehicle access, although the topography slopes downward to the north and graves begin within about 15 feet of the entrance. While

Figure 17. High Street with Tolson’s Chapel to the right looking west. The alley along the west side of the cemetery is shown leading off High Street. Note also the slope from the road up to the chapel building.

there is no fence along the west and south sides, steep banks prevent most vehicles from gaining access. Along the entire east side there are wood and block fences or retaining walls. There is no vehicular circulation within the cemetery itself.

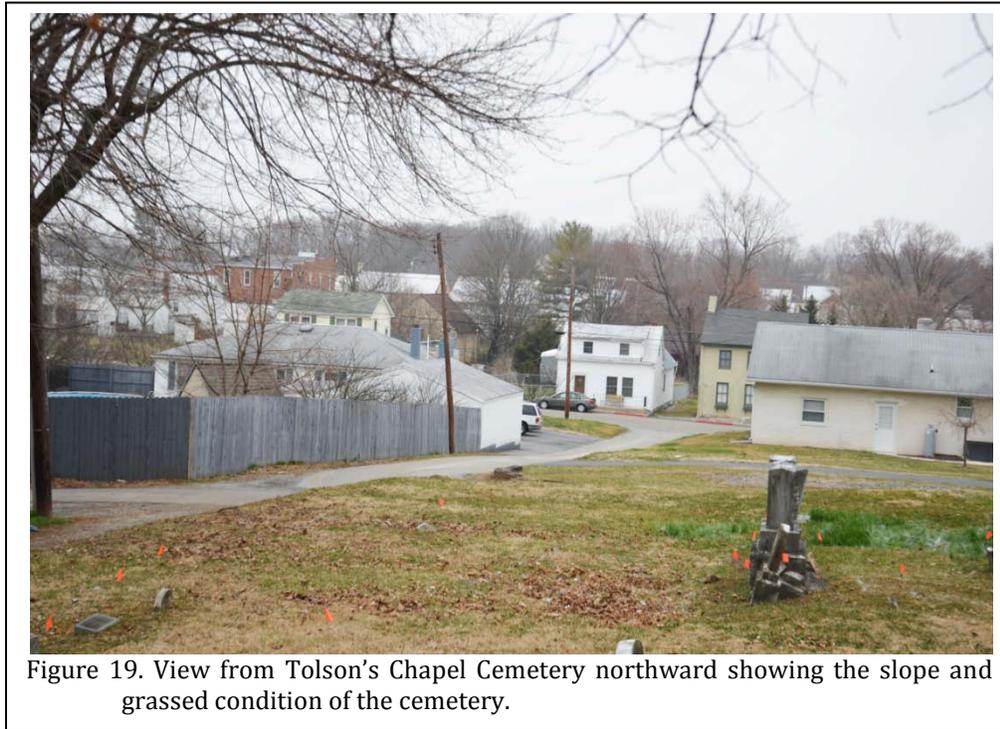
Figure 19. View from Tolson's Chapel Cemetery northward showing the slope and grassed condition of the cemetery.

The steps to the left (west) of the chapel are not accessible and lack a handrail. Whether this is an issue depends on whether these steps are owned by Sharpsburg or by FOTC.

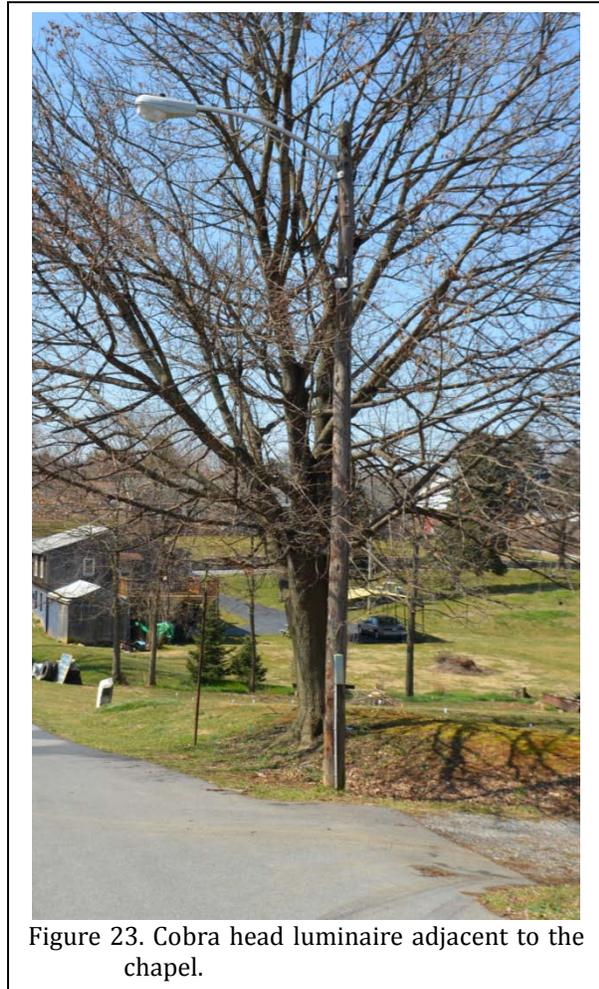
Figure 23. Cobra head luminaire adjacent to the chapel.

There is a standard single arm steel bracket with cobra head luminaire mounted on a utility pole southwest of the chapel, adjacent to the alleyway. We do not recommend that any additional lighting be installed.

Lighting is adequate and we do not recommend any additions.

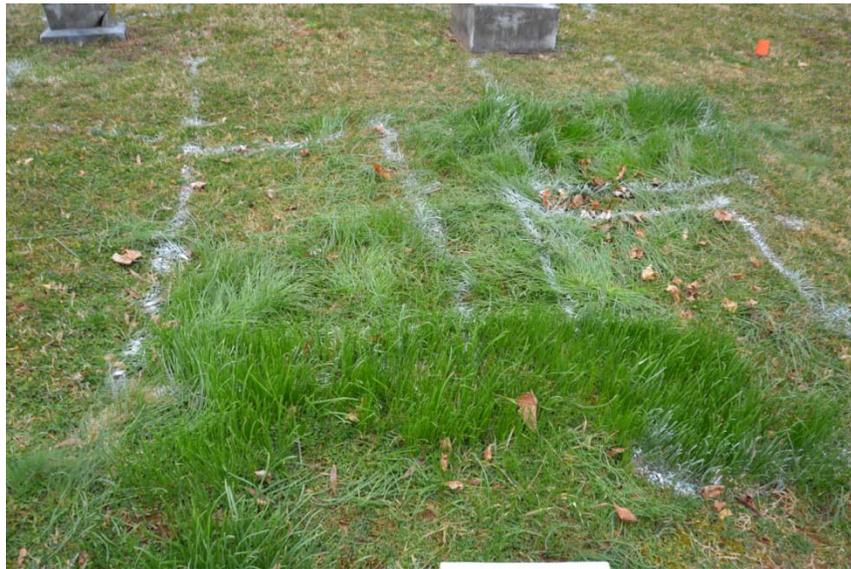
In several areas there are very large stands of wild garlic (*Allium vineale*). A good introduction to this weed is <http://www.clemson.edu/extension/hgic/pests/pdf/hgic2311.pdf> (Figure 26).

Figure 26. Weeds in the cemetery showing a large stand of wild garlic. While the turf is still dormant, the weeds already suggest the need to mow.

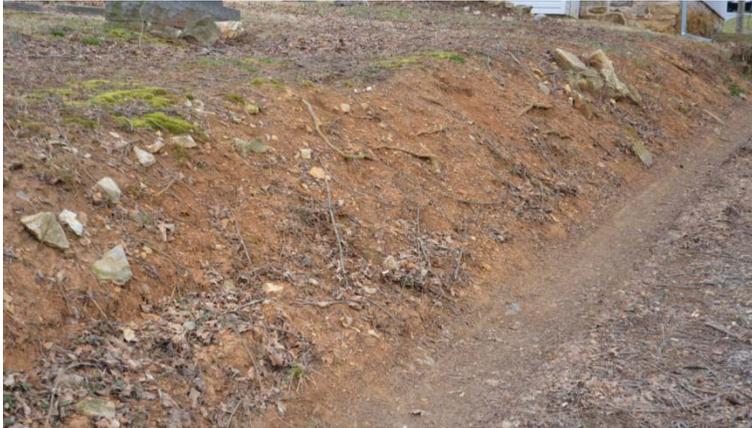
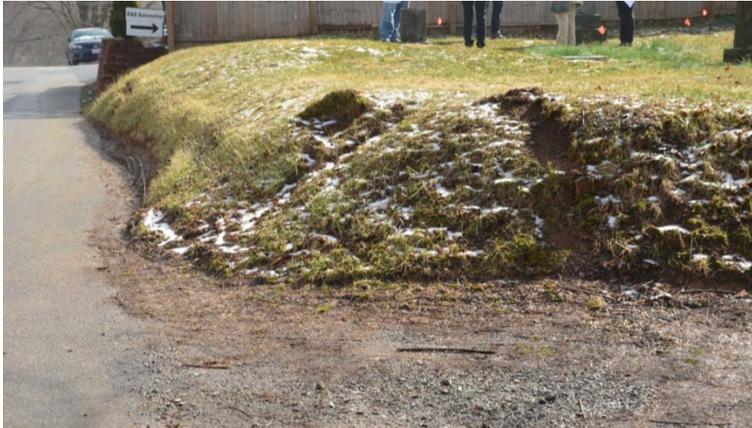
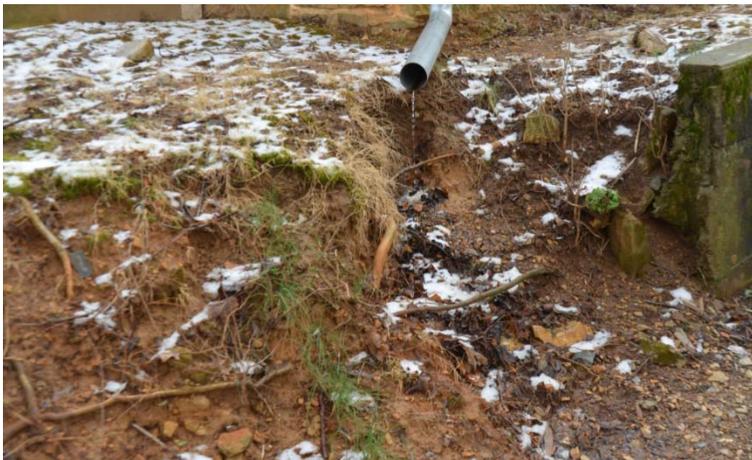
Figure 28. Erosion at the cemetery. The upper photo shows erosion along the west bank. The middle photo shows erosion from using the northwest corner as a bicycle ramp. The bottom photo shows erosion from a church building gutter draining directly onto the slope.

As Figure 28 reveals, there is erosion along the bank at the western and northern edges of the cemetery. Causes include shade from nearby trees, inappropriate drainage from the new roof, and the use of the slope as a bicycle ramp.

To minimize the use of the northern cemetery slope as a bicycle ramp we recommend the installation of hand placed rip-rap softened with the planting of a hardy, low maintenance ground cover such as lirioppe. This is likely more effective, easier to integrate into the historic landscape, and will require less maintenance than a fence.

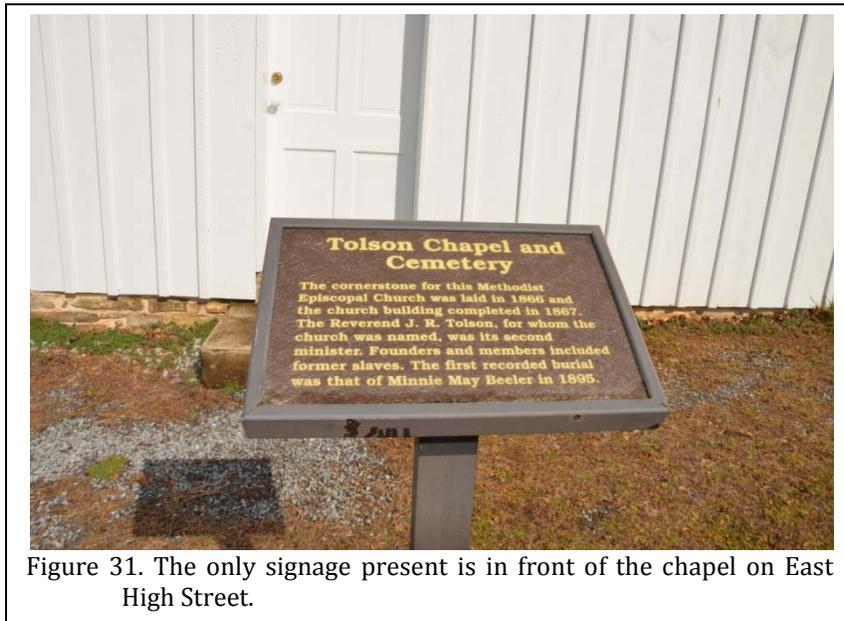
Regulatory signage specifies laws, regulations, or expected standards of behavior. There is no regulatory signage at the cemetery and this should receive a very high priority. We recommend the following items be included in the regulations affecting the cemetery:

Figure 31. The only signage present is in front of the chapel on East High Street.

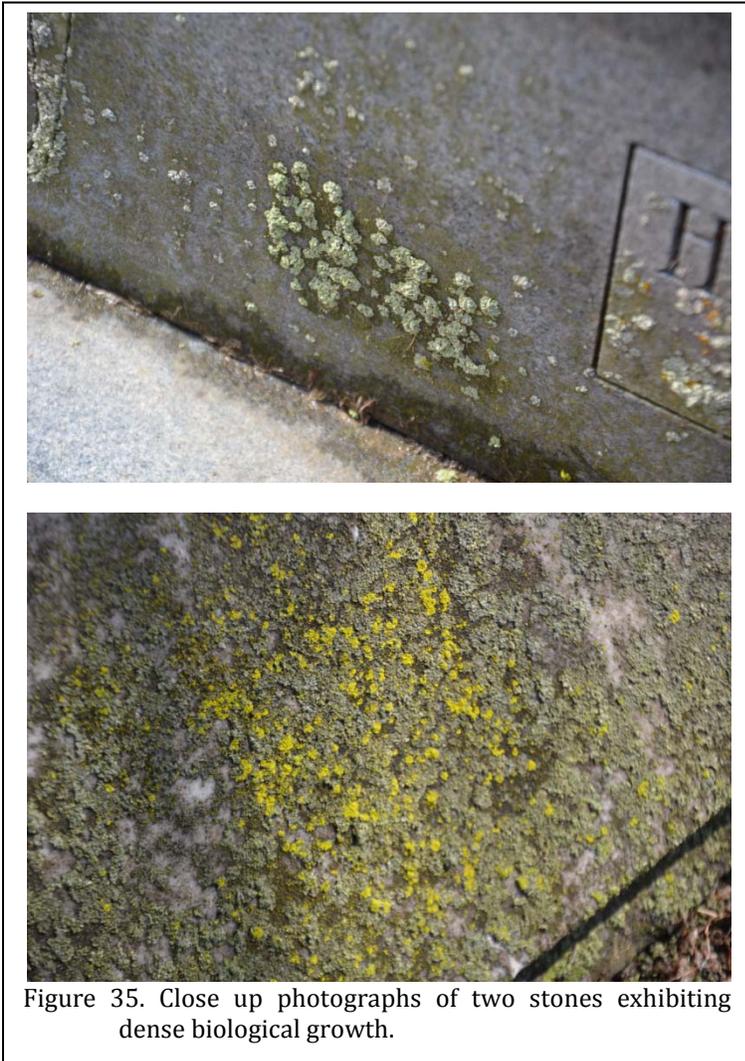
Figure 35. Close up photographs of two stones exhibiting dense biological growth.

A suitable biocide for cleaning stones is

D/2 Biological Solution (<http://d2bio.com/>) available from a variety of conservation suppliers. Stones should always be prewetted prior to application of D/2 and after dwelling for a few minutes followed by gentle scrubbing, should be flushed from the stone.

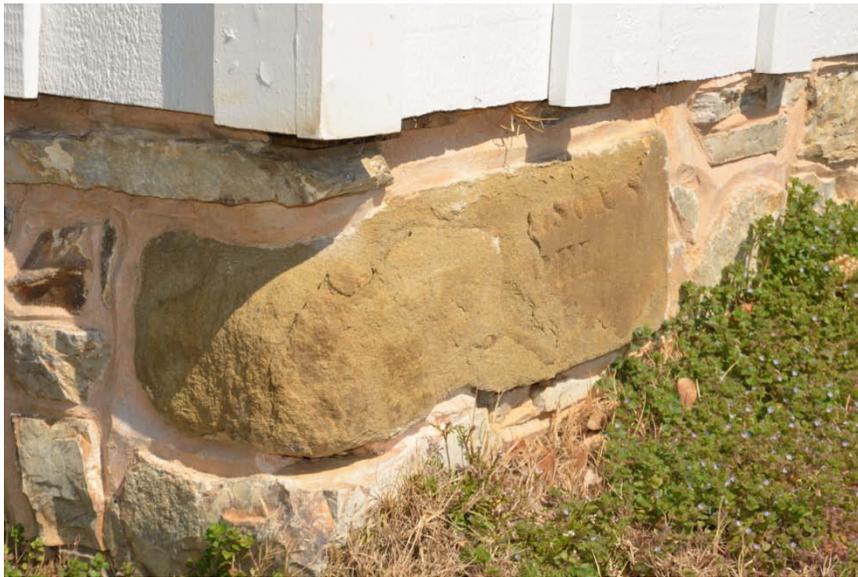
While not specifically included in this project, it may be useful to briefly mention the badly deteriorated condition of the Tolson's Chapel cornerstone (Figure 36).

Figure 36. Cornerstone showing extensive spalling of the sandstone with the loss of most of the original carving.

All repairs in the Cemetery should be conducted by trained conservators who subscribe to the Code of Ethics and Guidelines for Practice of the American Institute for Conservation of Historic and Artistic Works (AIC). This should be the minimum level of competency required by FOTC on all projects.

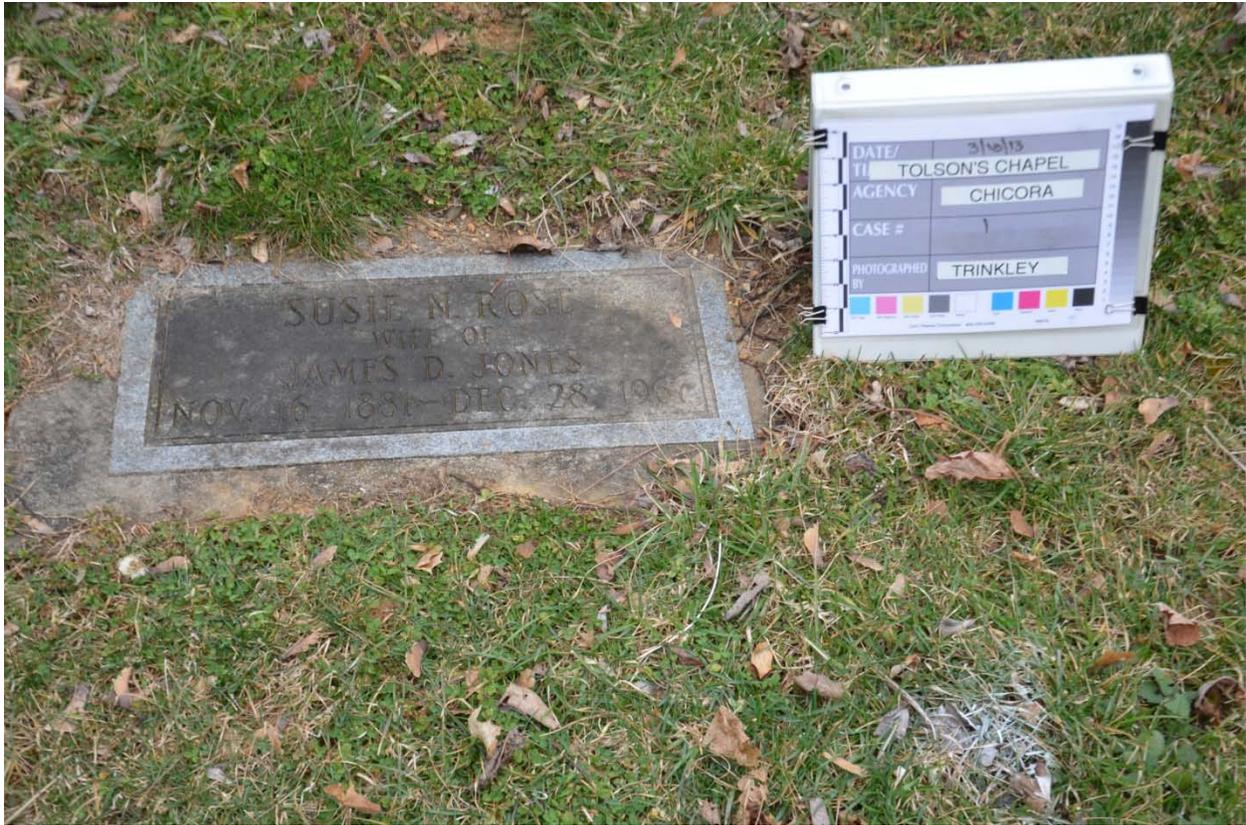
SUSIE N. ROSE
WIFE OF
JAMES D. JONES
NOV. 16 1881 - DEC. 28 1966

Priority: 3

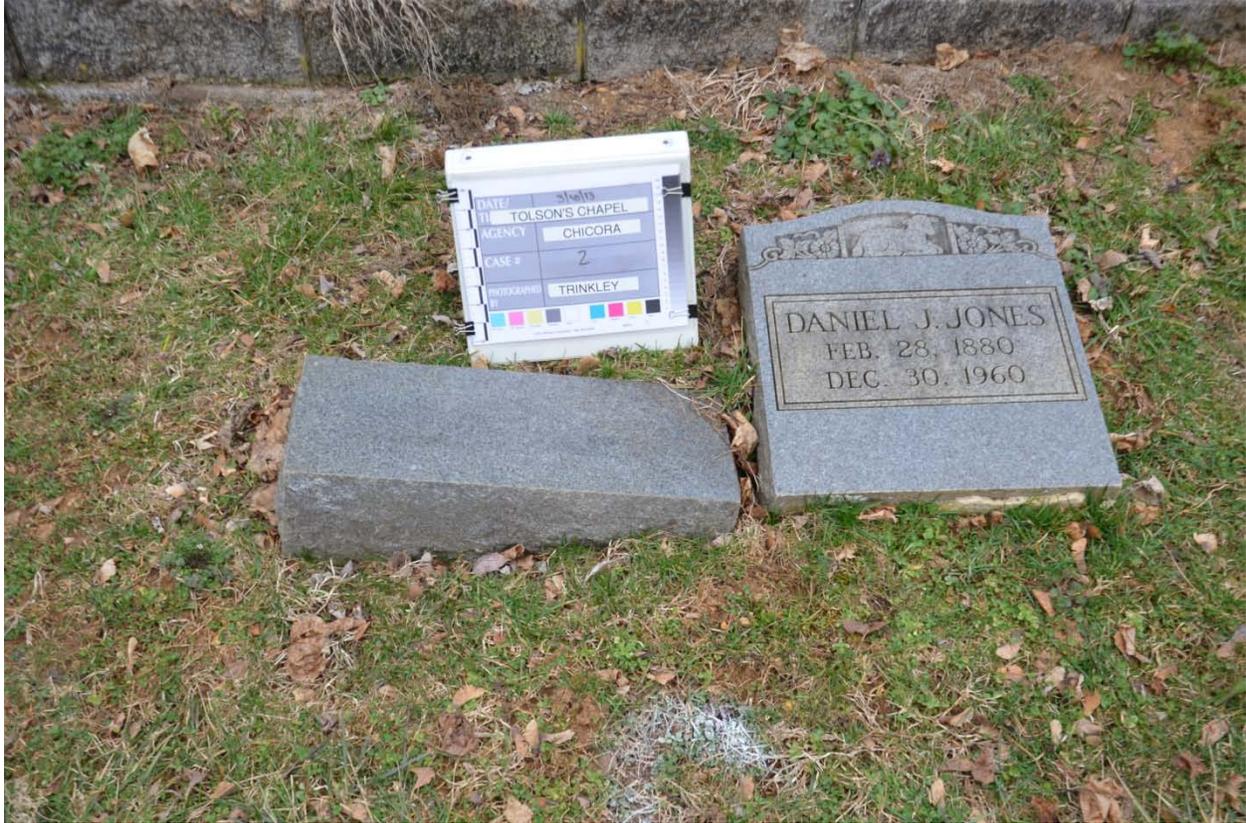
DANIEL J. JONES
FEB. 28, 1880
DEC. 30, 1960

Priority: 3

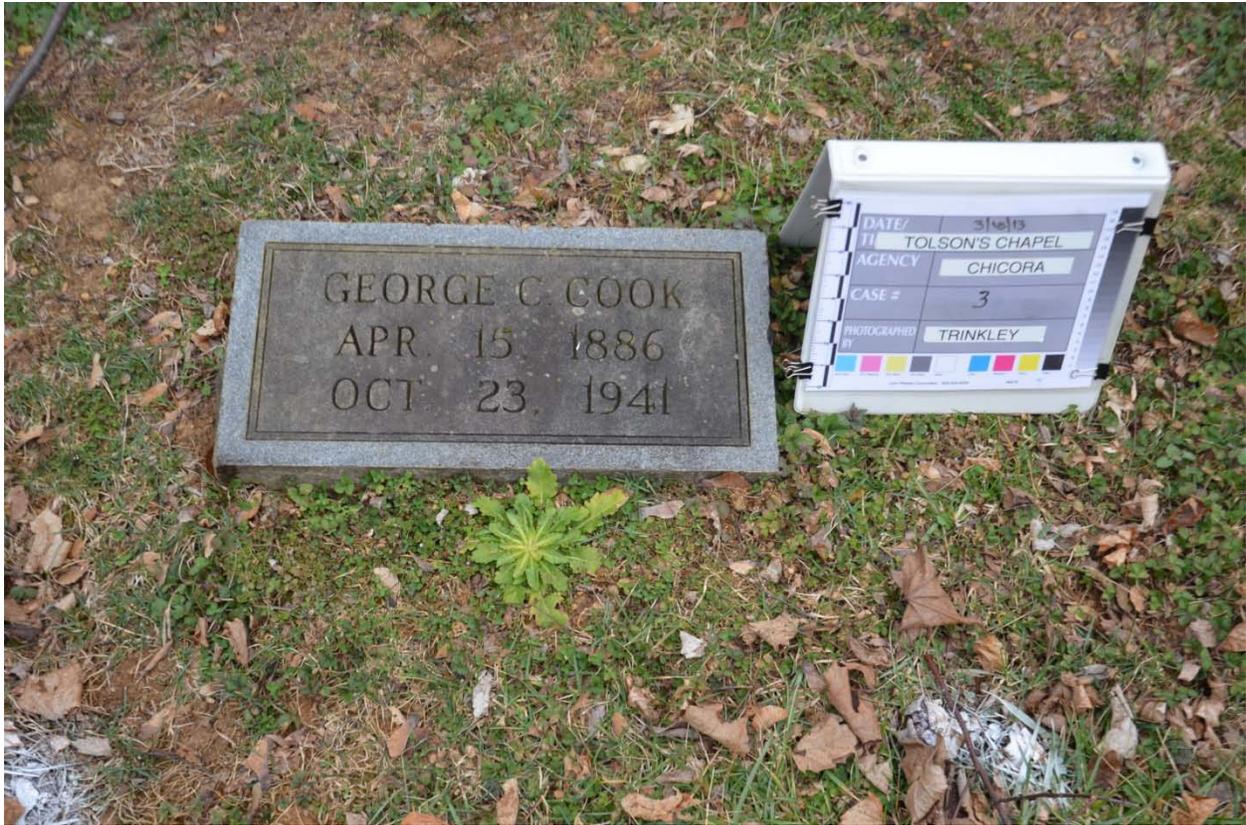
GEORGE C COOK
APR. 15 1886
OCT. 23 1941

Priority: 3

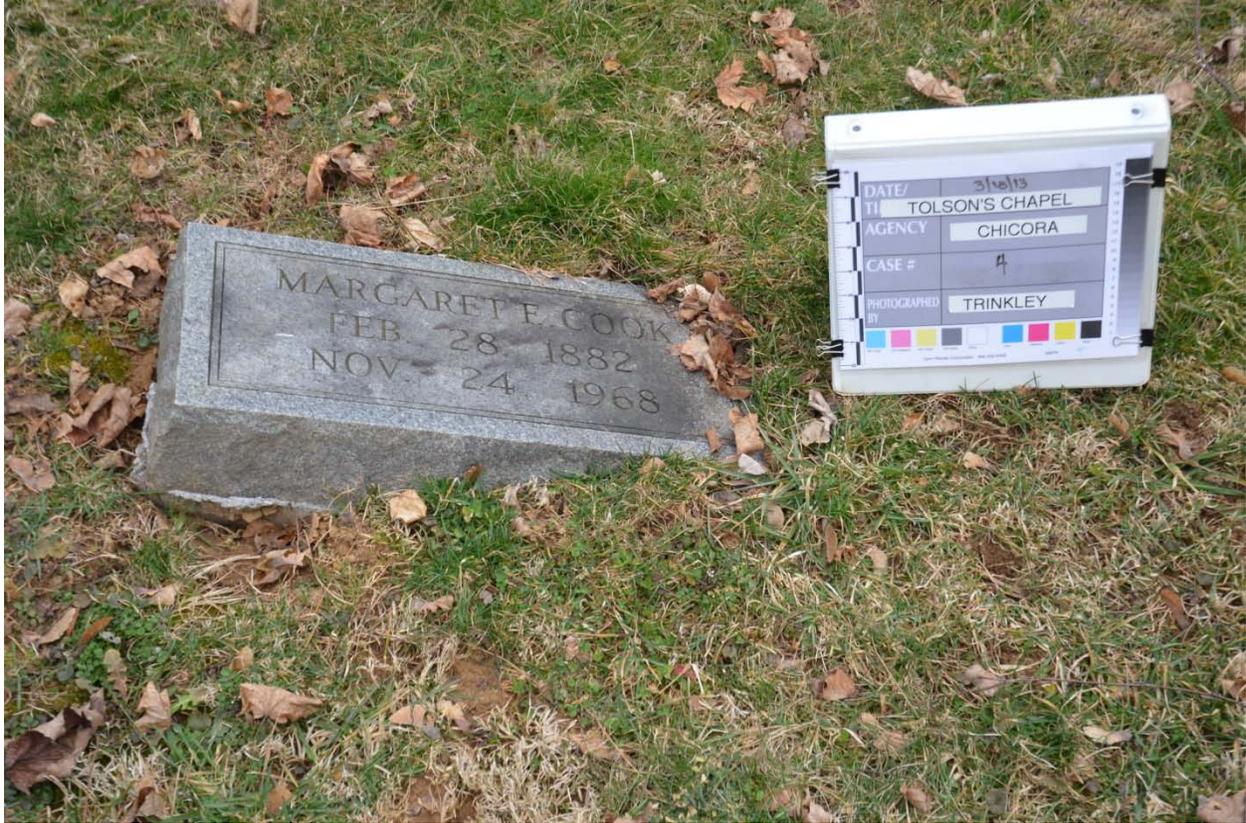
MARGARET E. COOK
FEB. 28 1882
NOV. 24 1968

Priority: 3

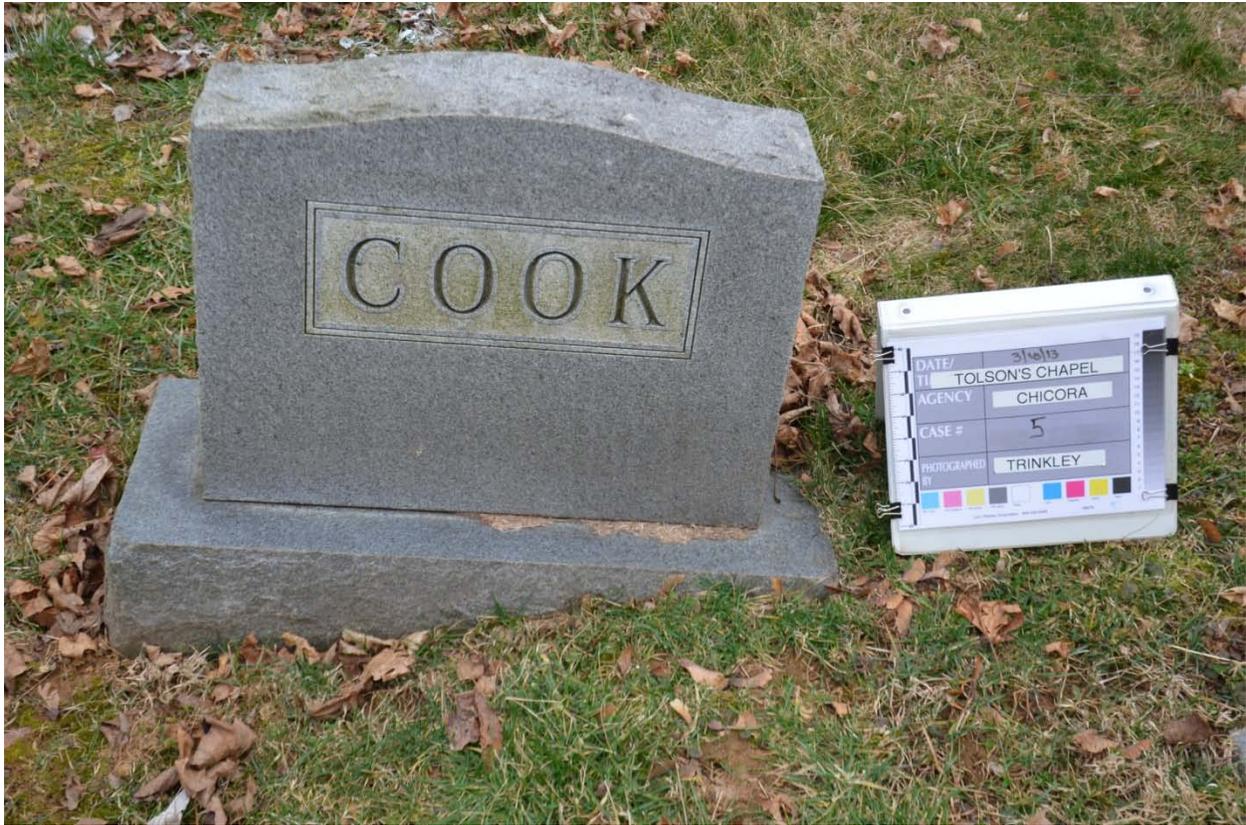
COOK

Priority: 3

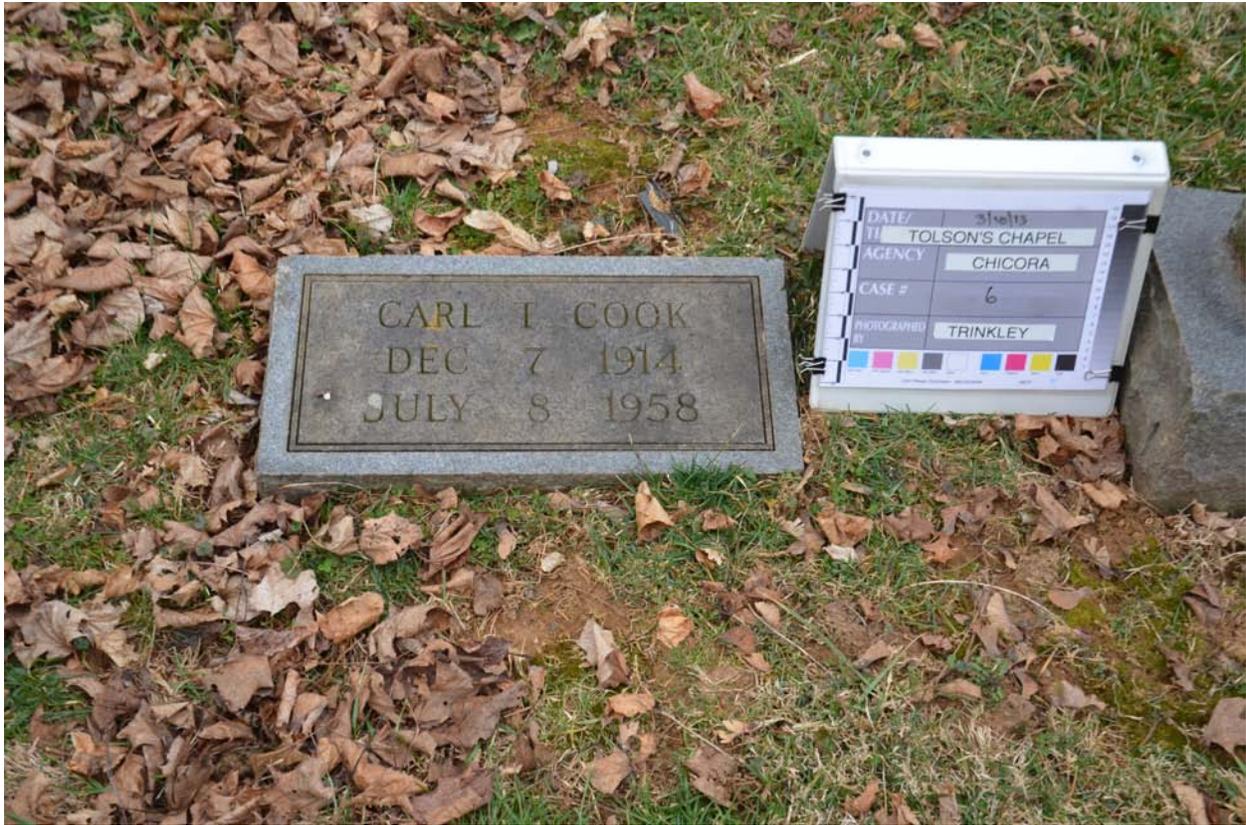
CARL T. COOK
DEC 7 1914
JULY 8 1958

Priority: 4

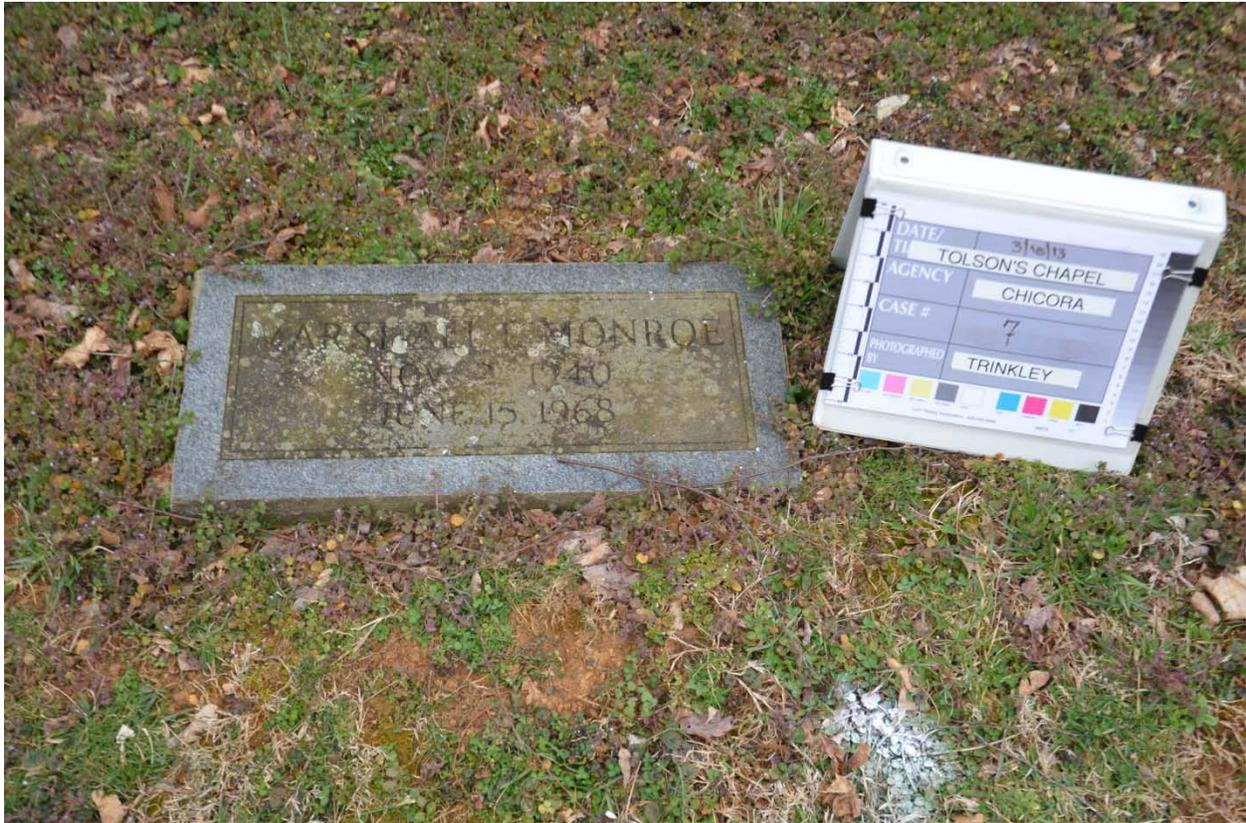
MARSHALL L. MONROE
NOV 2 1940
JUNE 15 1968

Priority: 3

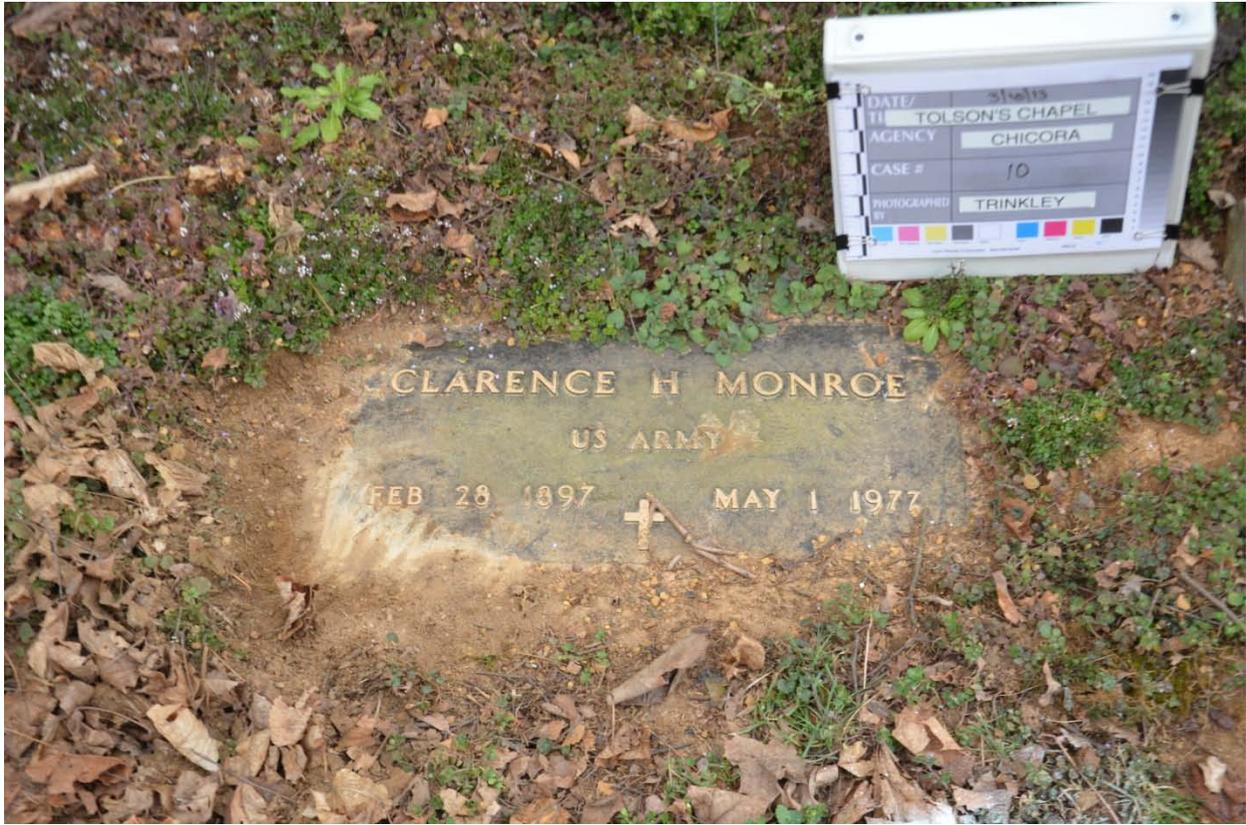
CLARENCE H MONROE
US ARMY
FEB 28 1897 + MAY 1 1977

Priority: 3

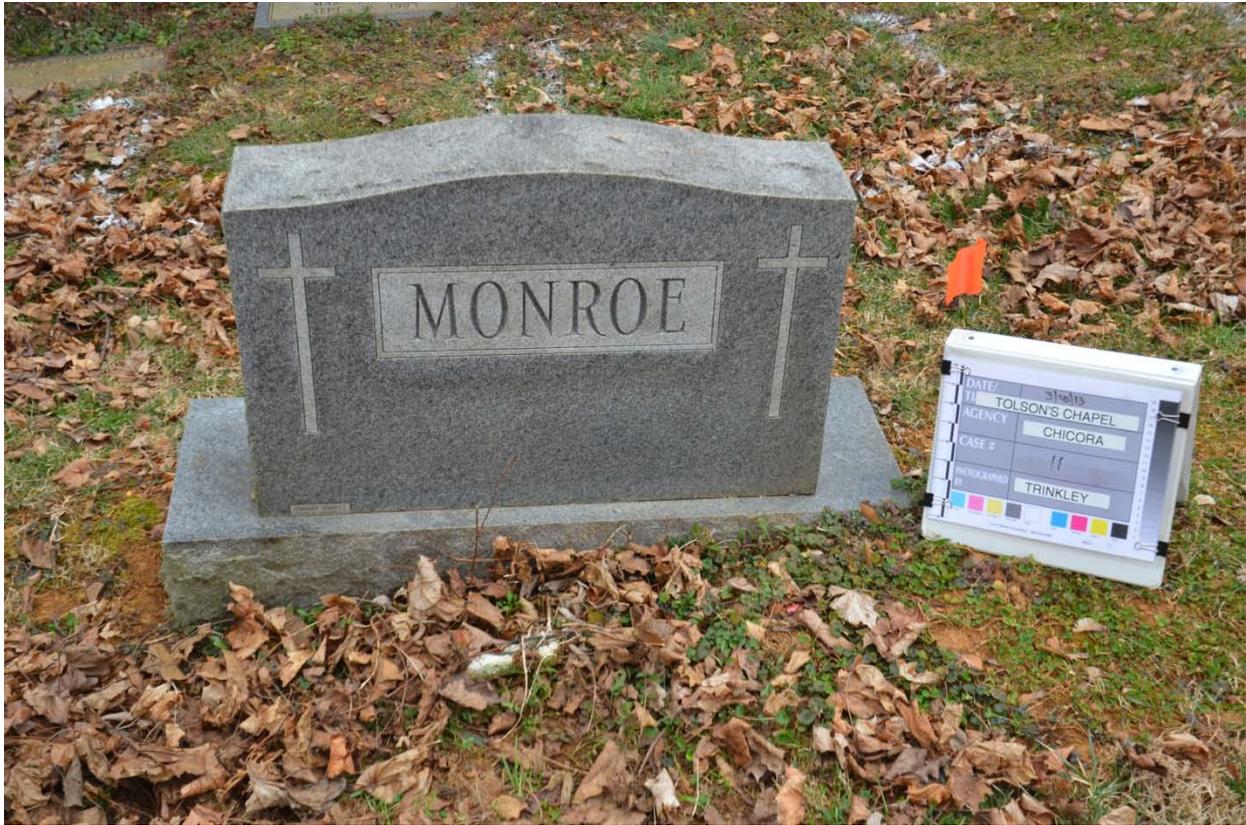
MONROE

Priority: 3

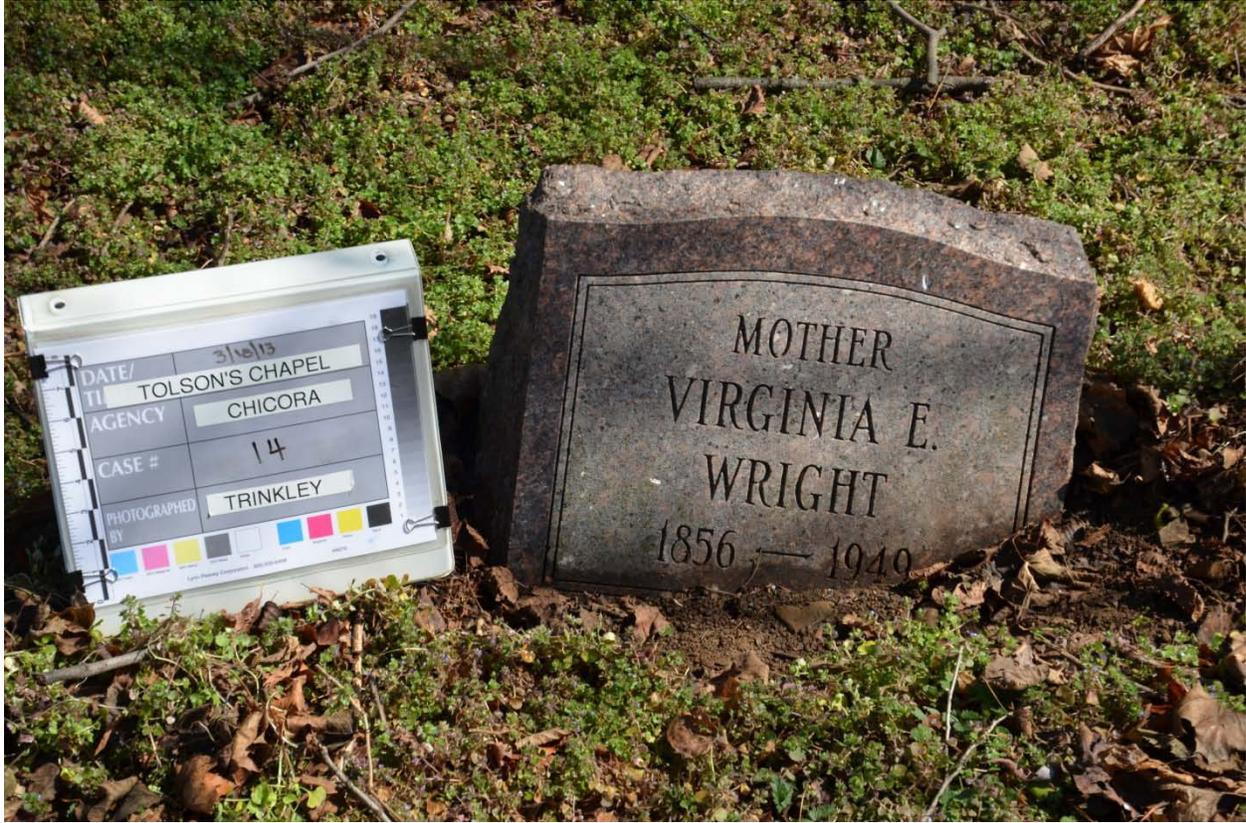
Failed/Old Treatments: metal adhesives/coatings mortar other: set in OPC

Treatment: core drill drill and pin simple adhesive repair injection grout replace bricks
 mortar repoint infill other: remove OPC

Priority: 3

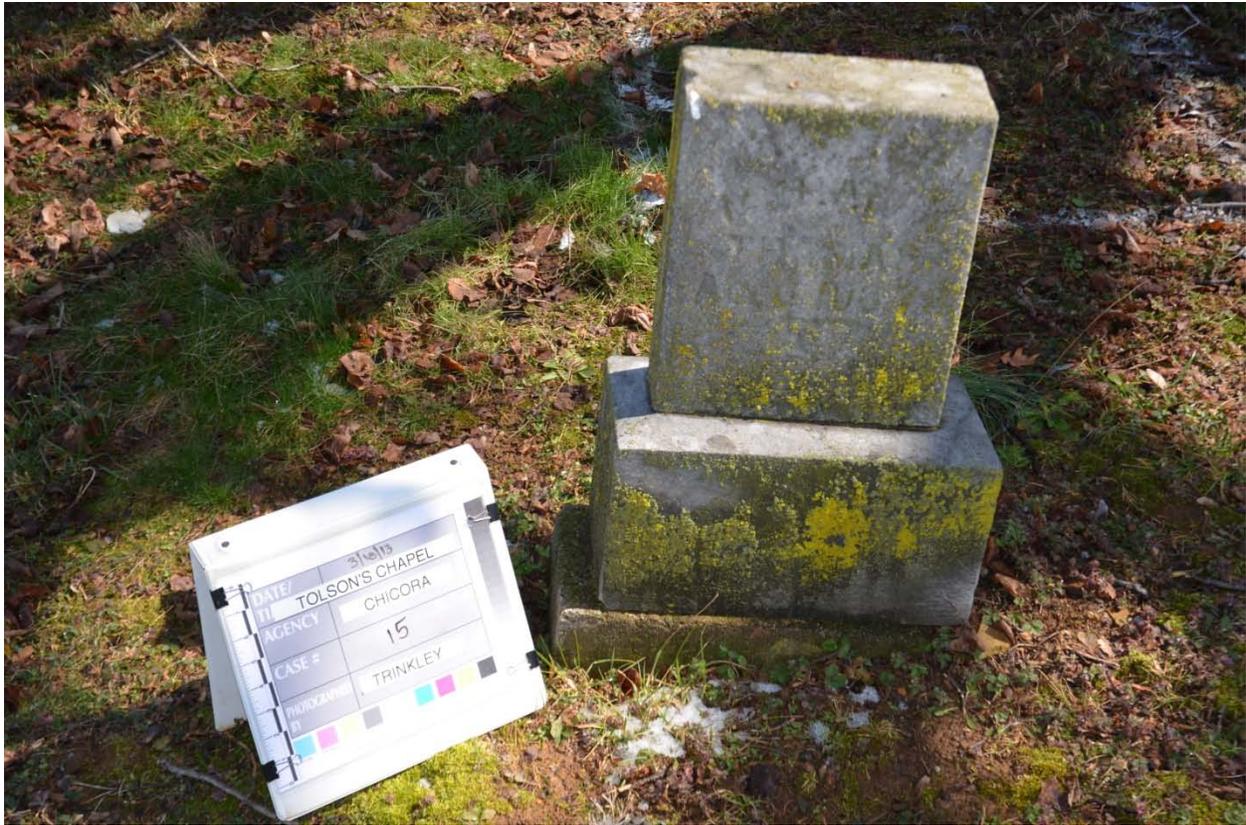
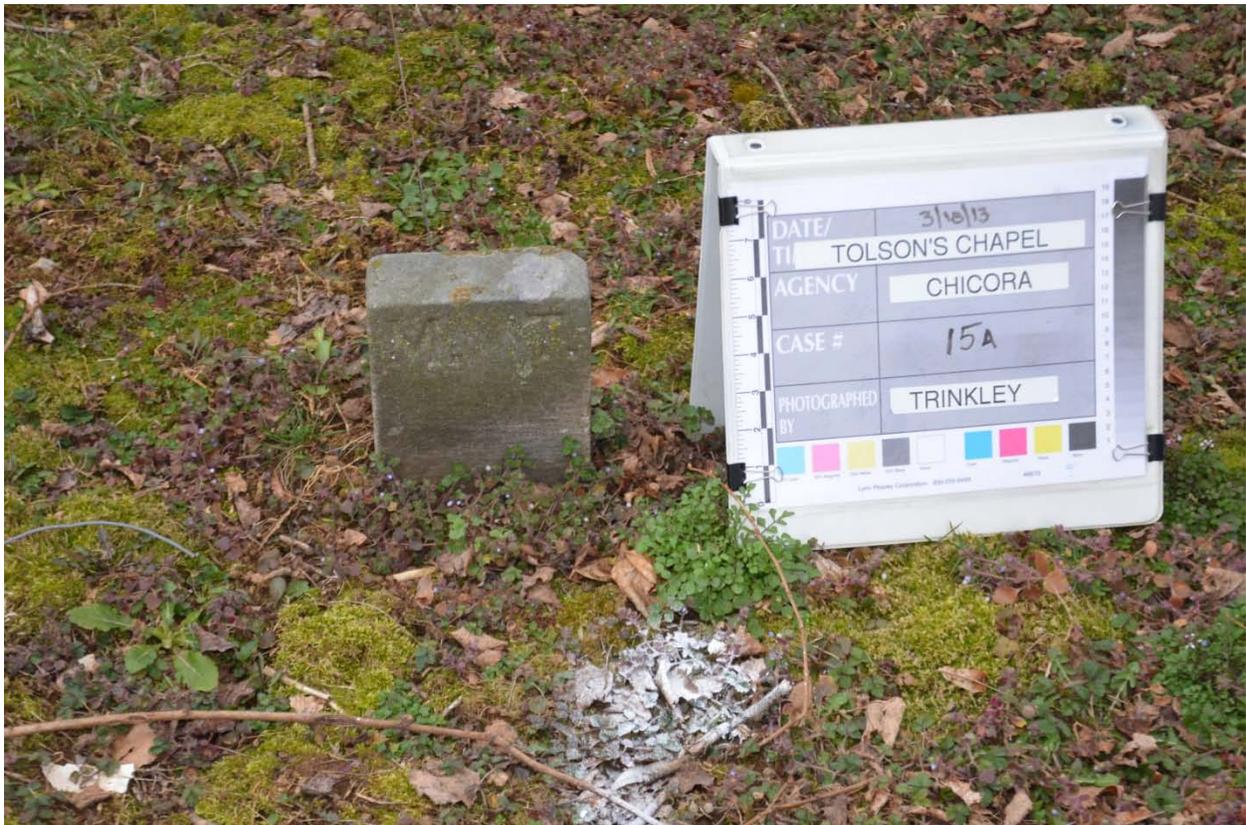
Footstone: **Material:** marble **Design/initials:** M. T. **Condition:** tilted, biologicals, mower damage

Position: reset/level in ground reset/level to existing base construct new base resquare
 possible new base required stabilize foundation reset with 1:2.5 NHL 3.5 mix reset with compound
 other: remove or bury OPC base

Treatment: core drill drill and pin simple adhesive repair injection grout replace bricks
 mortar repoint infill other: replace ferrous pin with fiberglass pin

Priority: 2

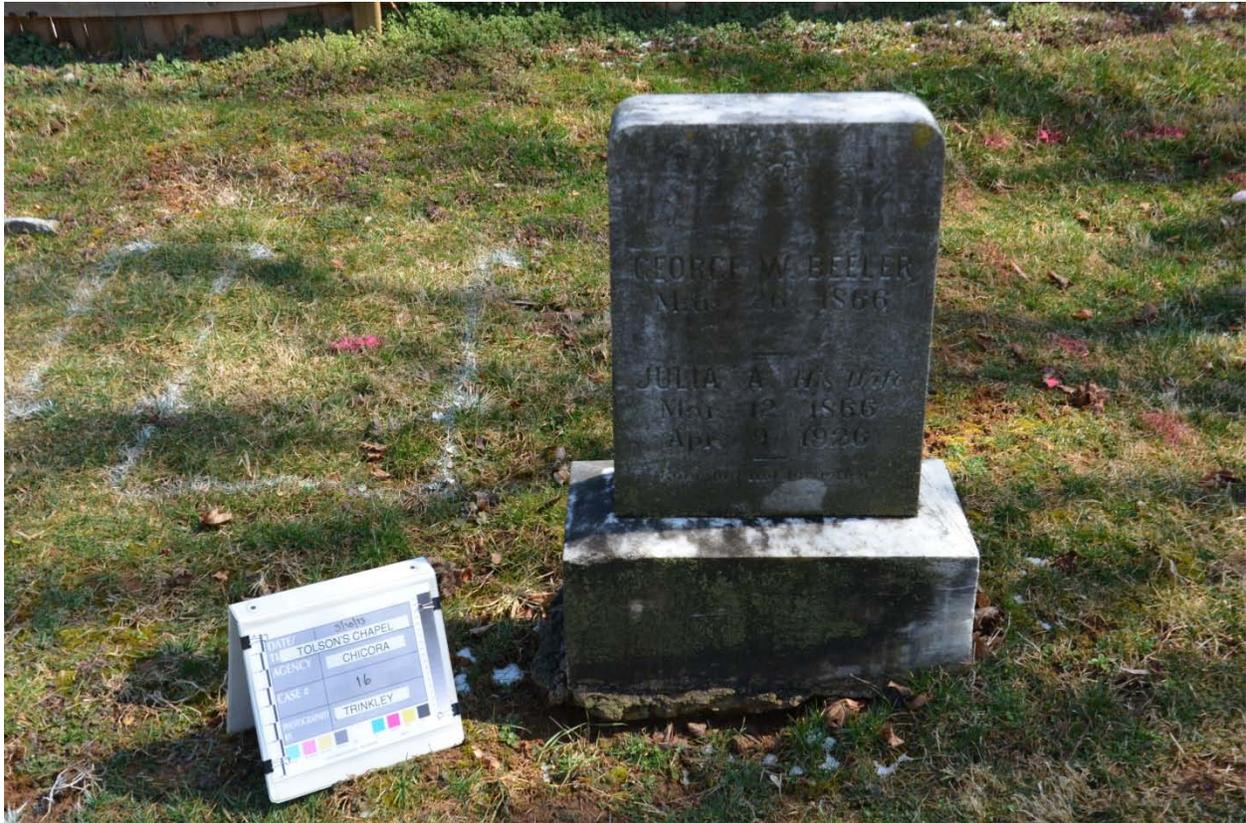
Failed/Old Treatments: metal adhesives/coatings mortar other: set in OPC

Treatment: core drill drill and pin simple adhesive repair injection grout replace bricks
 mortar repoint infill other: remove OPC; replace ferrous pin with fiberglass pin

Priority: 2

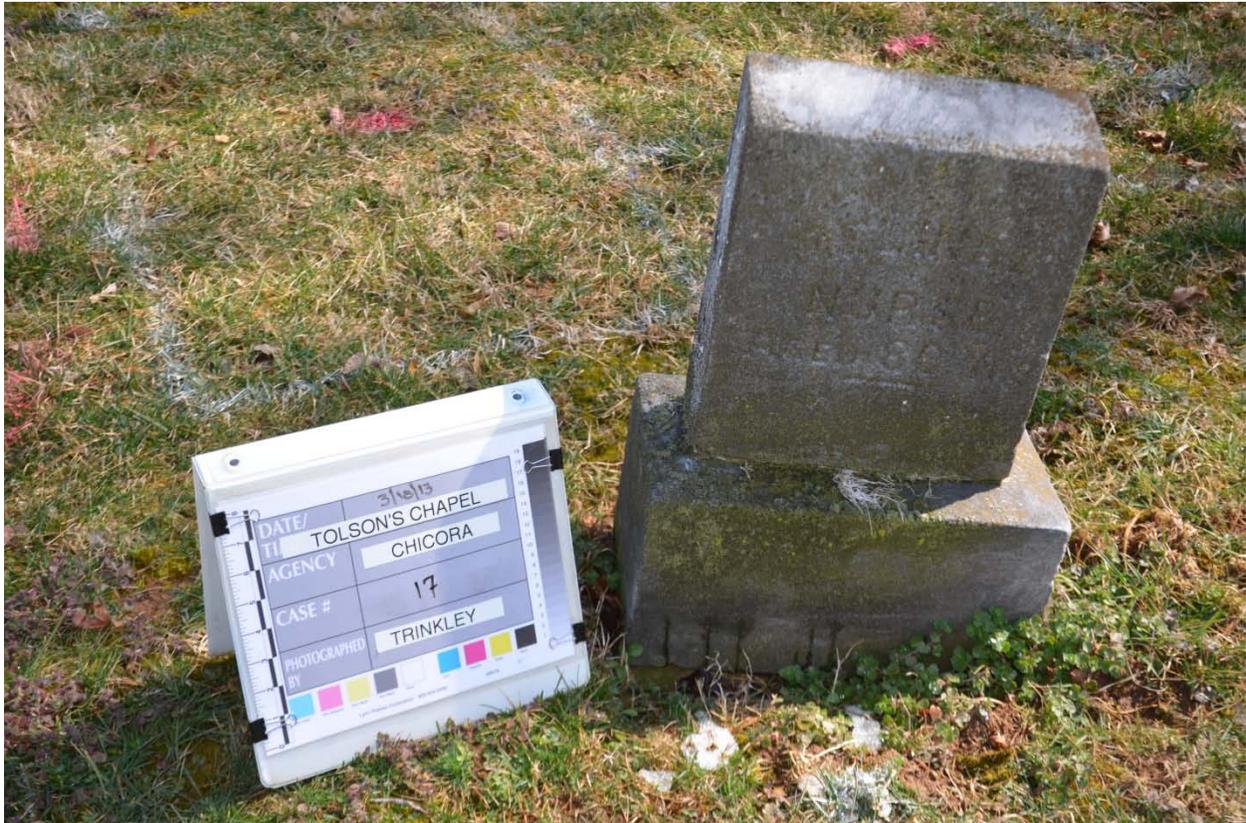
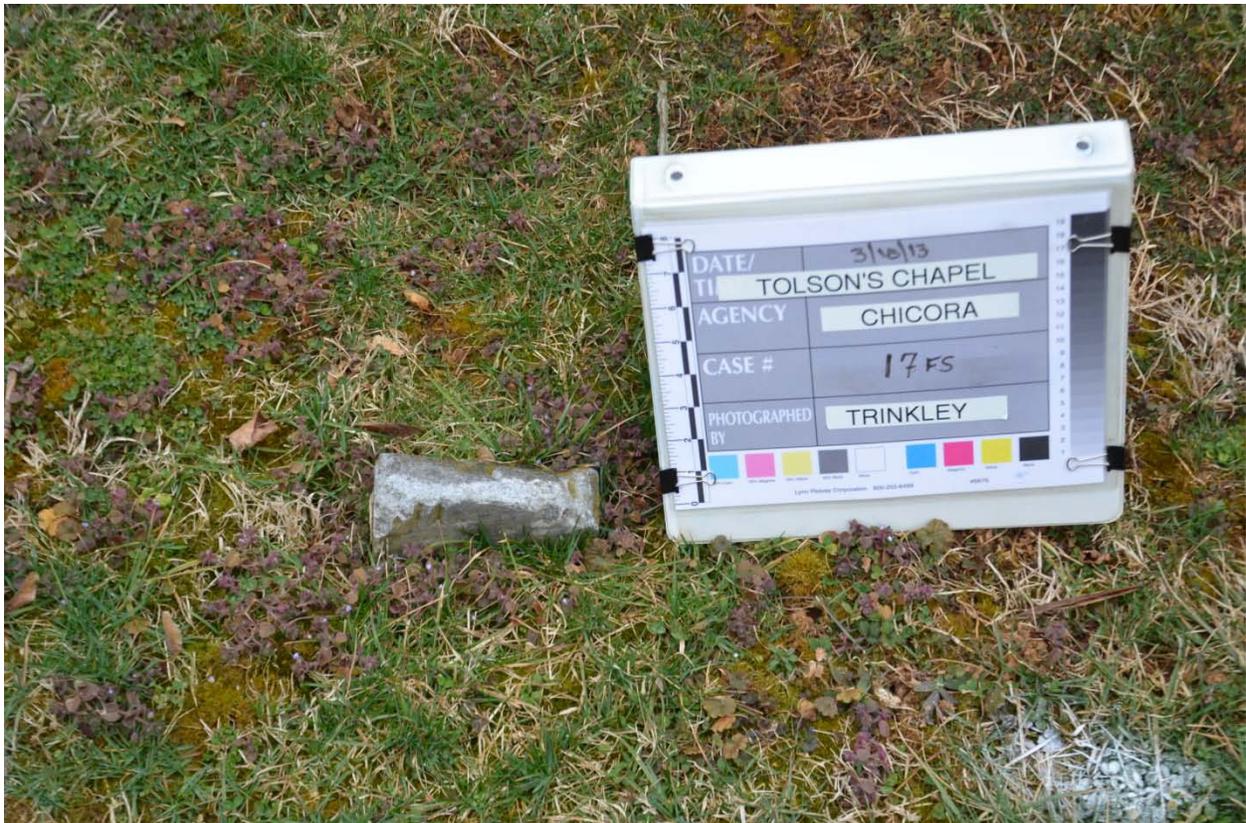
Footstone: **Material:** marble **Design/initials:** M. [N.] **Condition:** losses, extensive mower damage

Deterioration: broken cracked losses flaking/sugaring ferrous pins brass pins
 delamination/detachment spalling missing fragments other: set in/on OPC

Treatment: core drill drill and pin simple adhesive repair injection grout replace bricks
 mortar repoint infill other: remove OPC; replace ferrous pin with fiberglass pin

Priority: 2
