PRESERVATION ASSESSMENT OF TOLSON'S CHAPEL CEMETERY, SHARPSBURG, MARYLAND

Chicora Research Contribution 552

Prepared By:
Michael Trinkley, Ph.D.
and
Debi Hacker

May 1, 2013

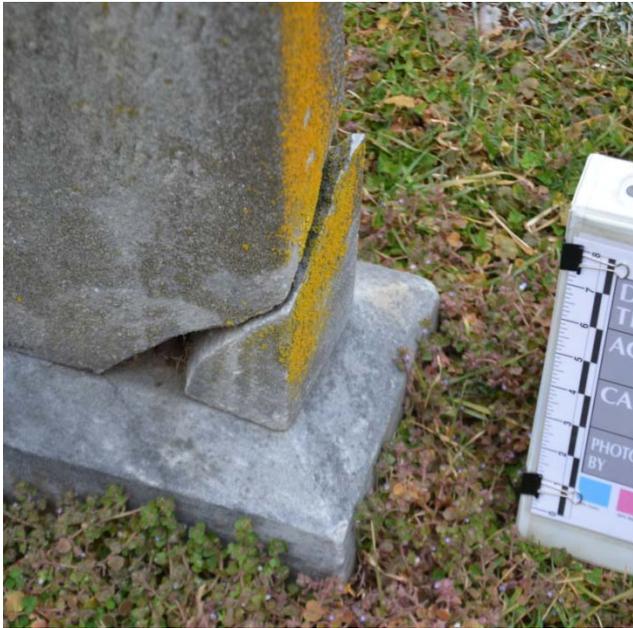
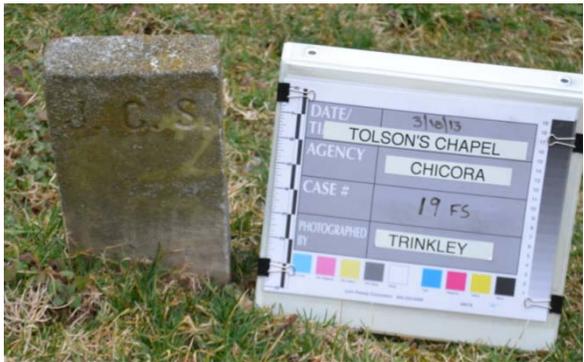
Footstone: **Material:** marble **Design/initials:** J.C.S. **Condition:** tilted, mower damage, biologicals

Deterioration: broken cracked losses flaking/sugaring ferrous pins brass pins
 delamination/detachment spalling missing fragments other: iron jacking, mower damage

Treatment: core drill drill and pin simple adhesive repair injection grout replace bricks
 mortar repoint infill other: replace ferrous pin with fiberglass; infill with Jahn M-120

Priority: 2

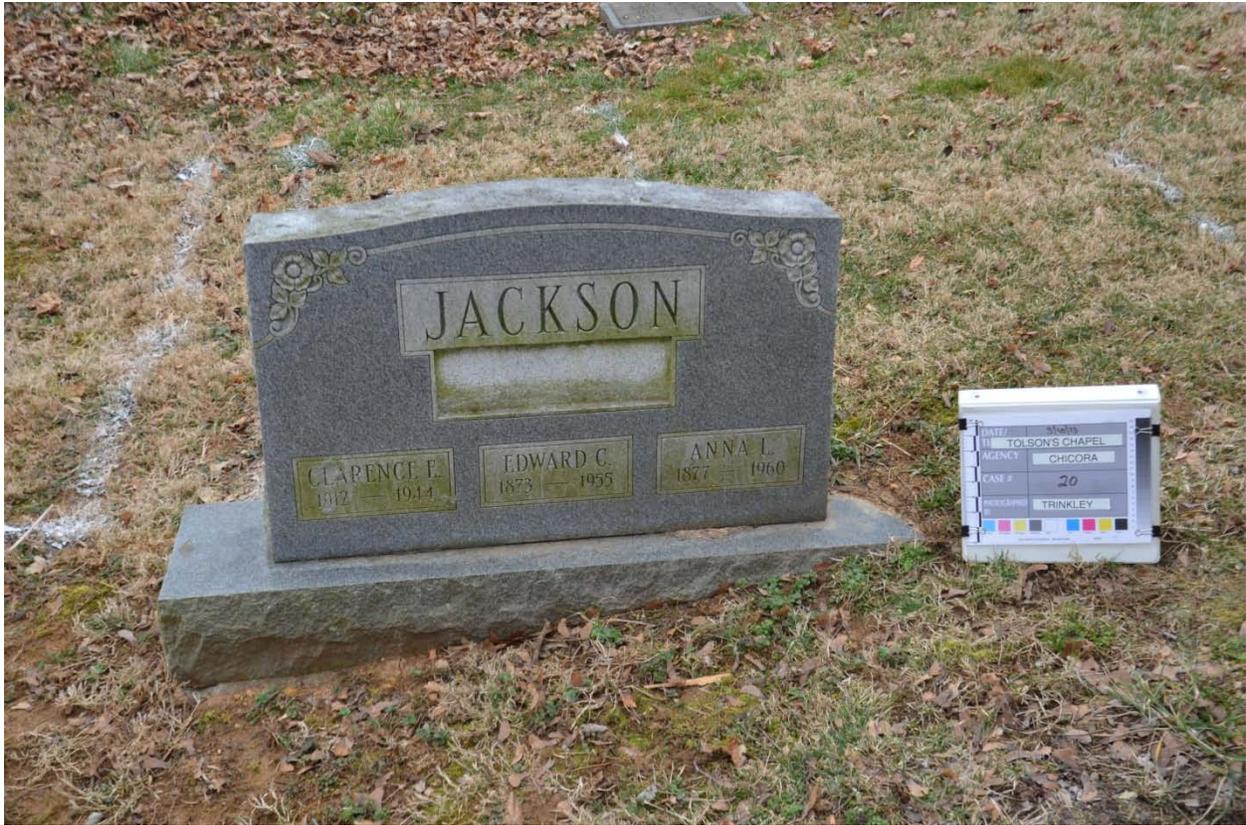
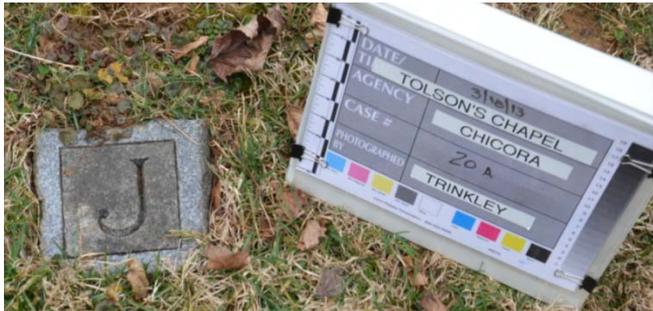
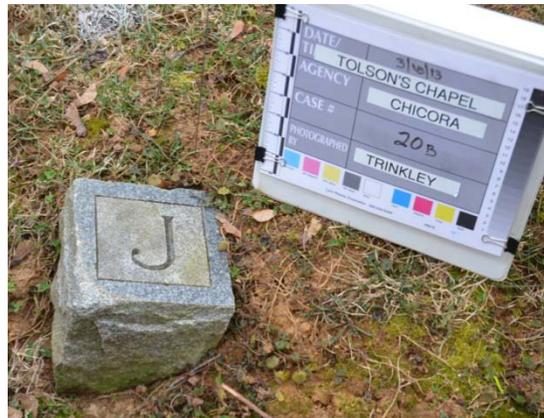
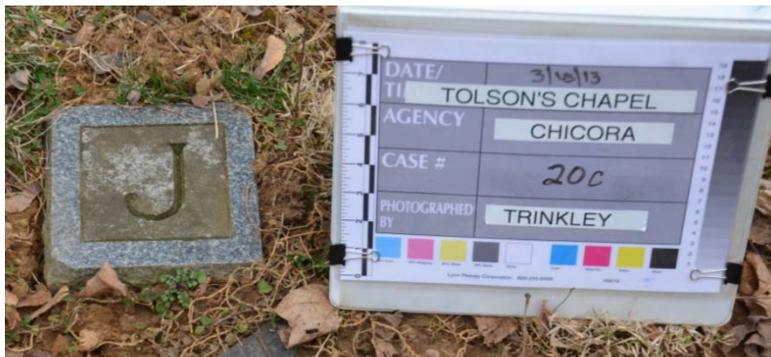
Coping: **Material:** granite **Design:** J **Condition:** tilted, sunken
 (3 corner markers, 6" x 6")

Failed/Old Treatments: metal adhesives/coatings mortar other: set in OPC

Priority: 3

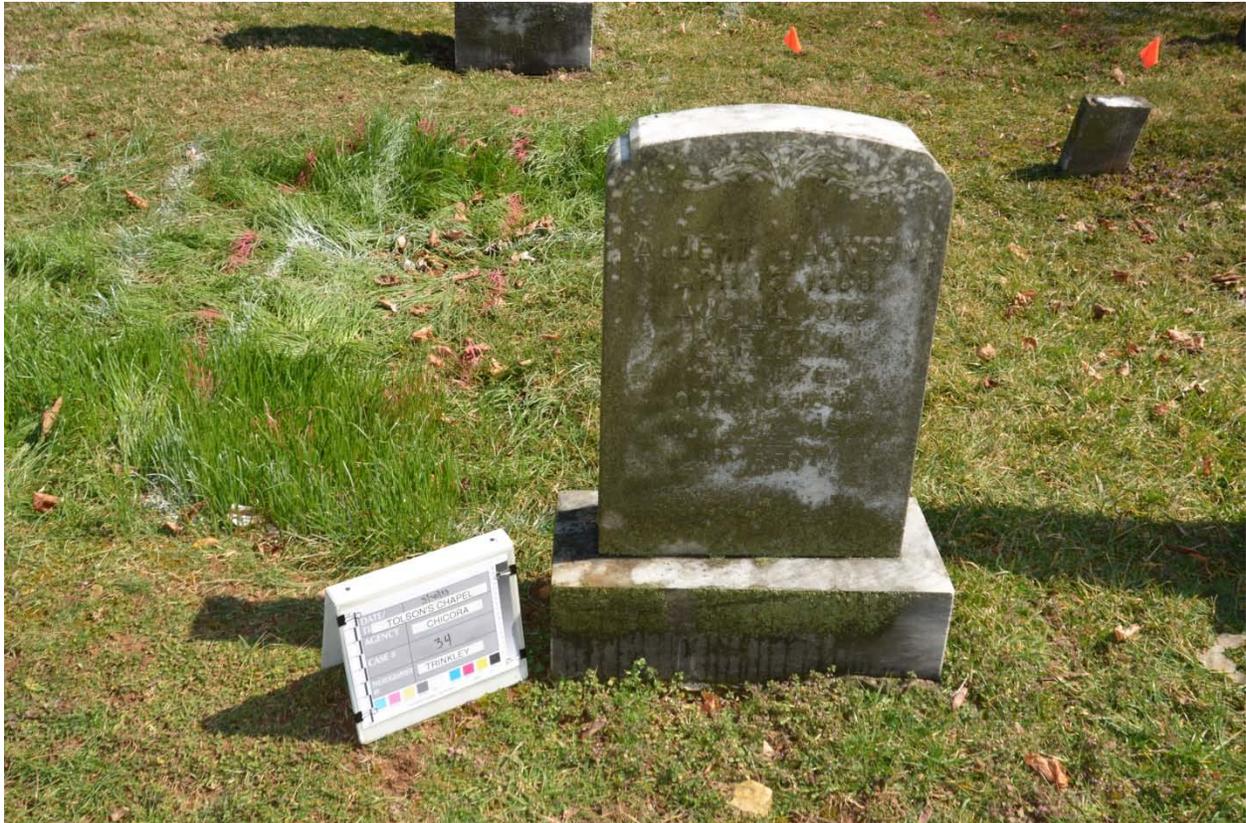
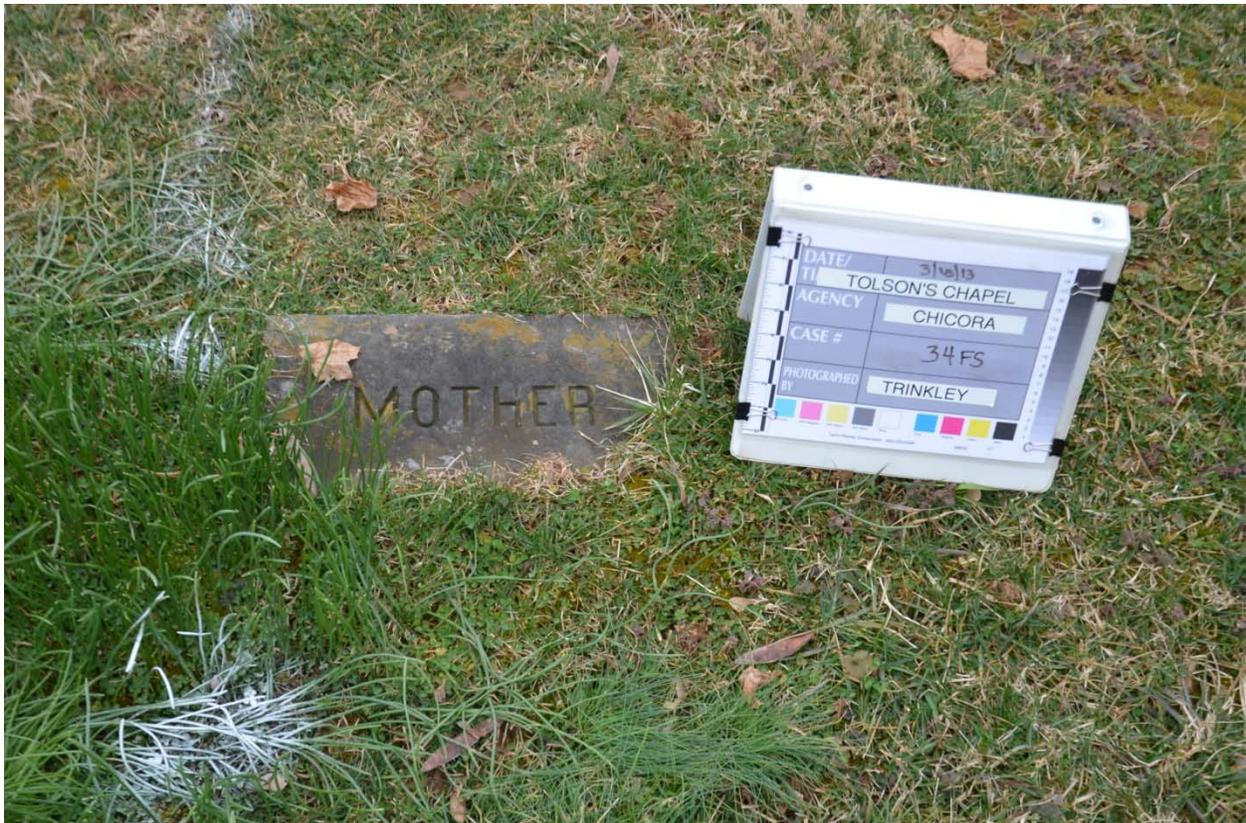
Priority: 3

Deterioration: broken cracked losses flaking/sugaring ferrous pins brass pins
 delamination/detachment spalling missing fragments other: edge damage, prob. mower

Position: reset/level in ground reset/level to existing base construct new base resquare
 possible new base required stabilize foundation reset with 1:2.5 NHL 3.5 mix reset with compound
 other: reset on new base to prevent theft

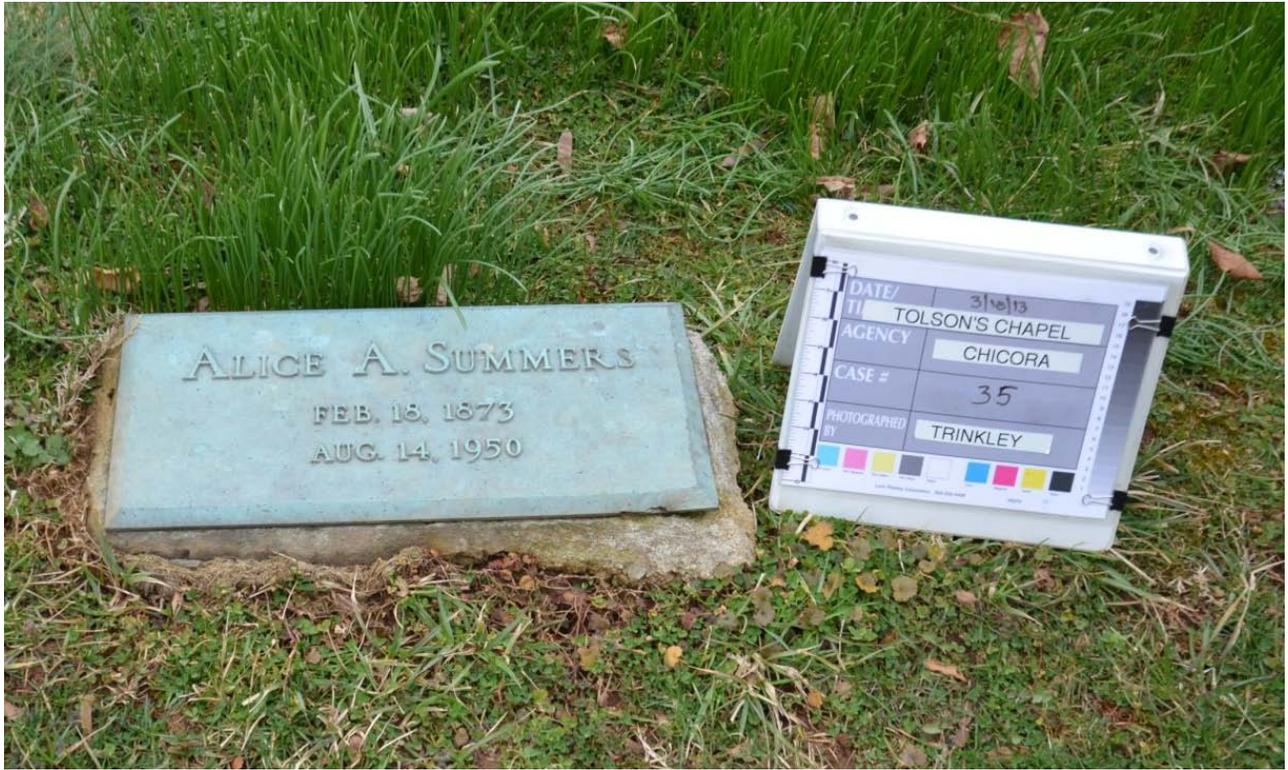
ALICE A. SUMMERS

Priority: 3

Failed/Old Treatments: metal adhesives/coatings mortar other: setting compound

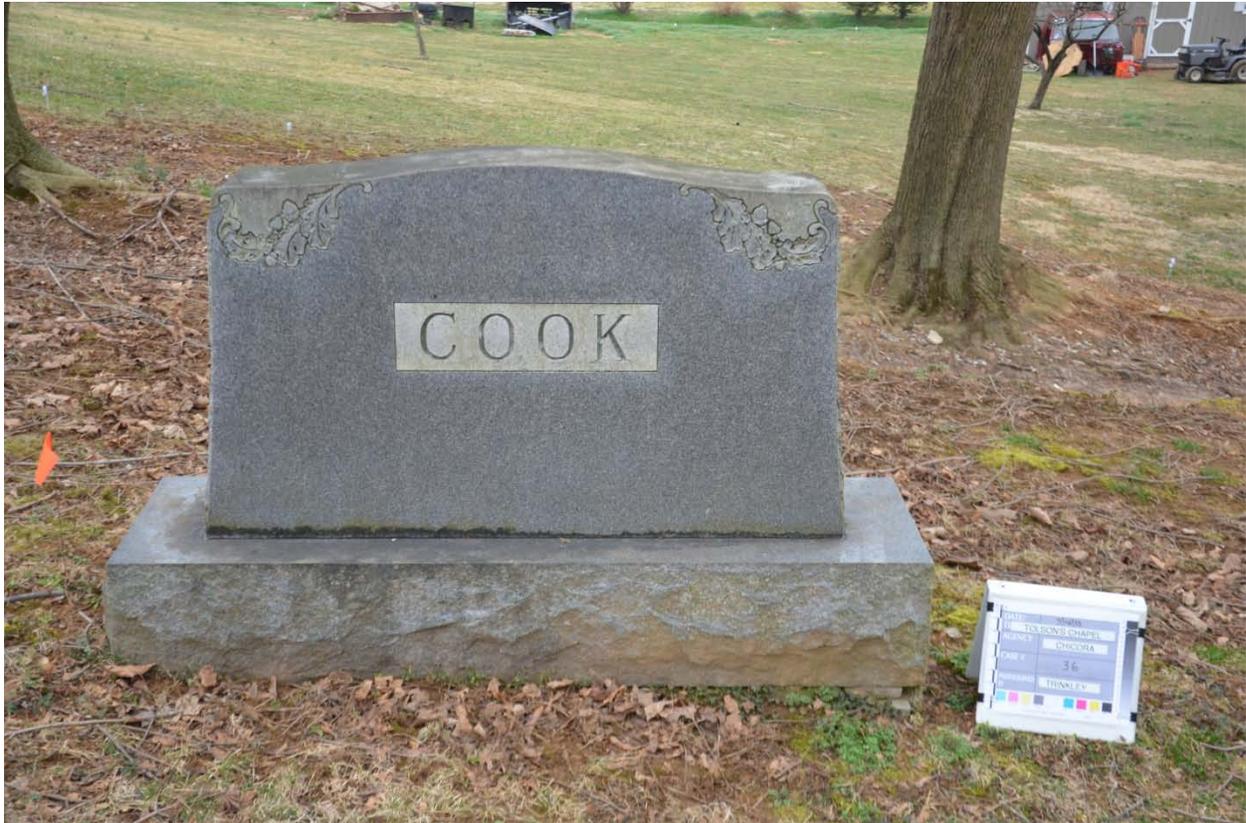
35408
TOLSON'S PHASE
CHOCOLA
36
THINKLE

Priority: 2

Deterioration: broken cracked losses flaking/sugaring ferrous pins brass pins
 delamination/detachment spalling missing fragments other: mower damage

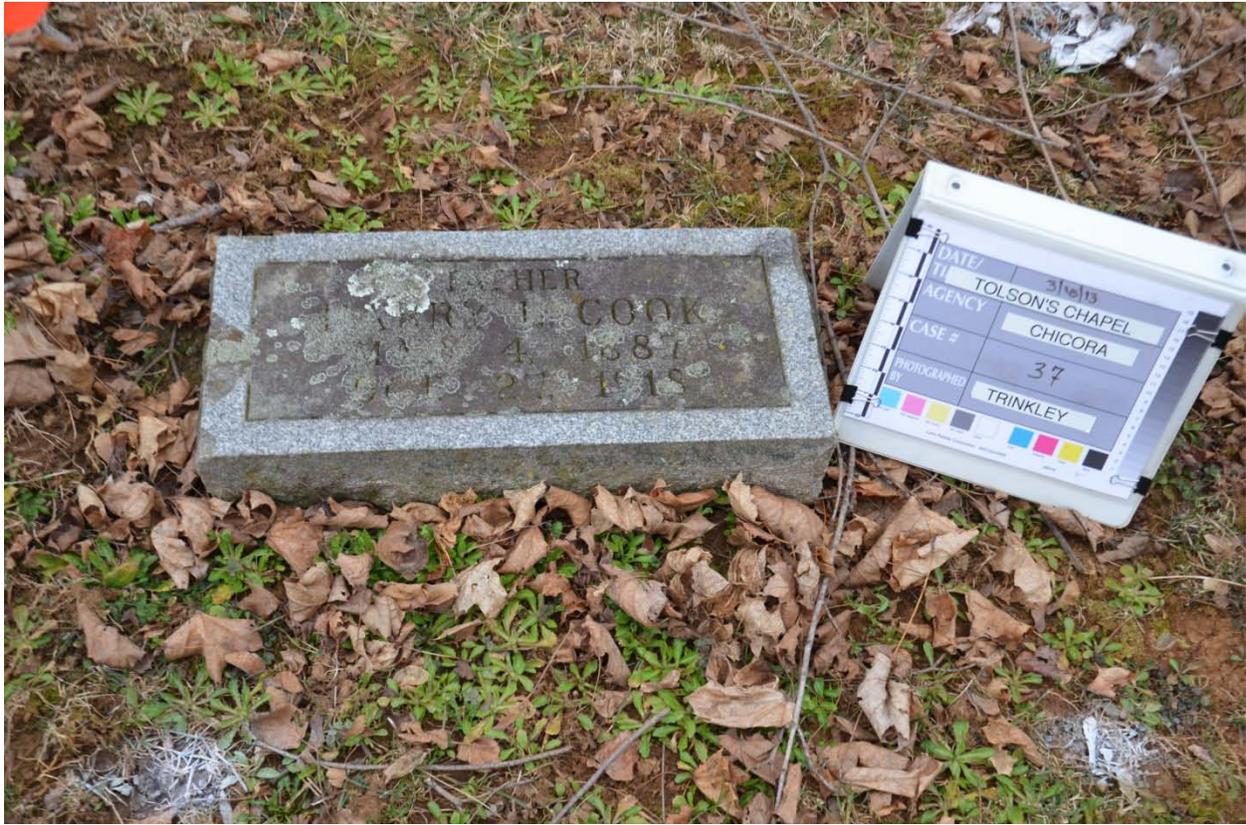
DATE/TIME	3/14/13
AGENCY	TOLSON'S CHAPEL
CASE #	CHICORA
PHOTOGRAPHER	37
BY	TRINKLEY

Priority: 3

Deterioration: broken cracked losses flaking/sugaring ferrous pins brass pins
 delamination/detachment spalling missing fragments other: mower damage

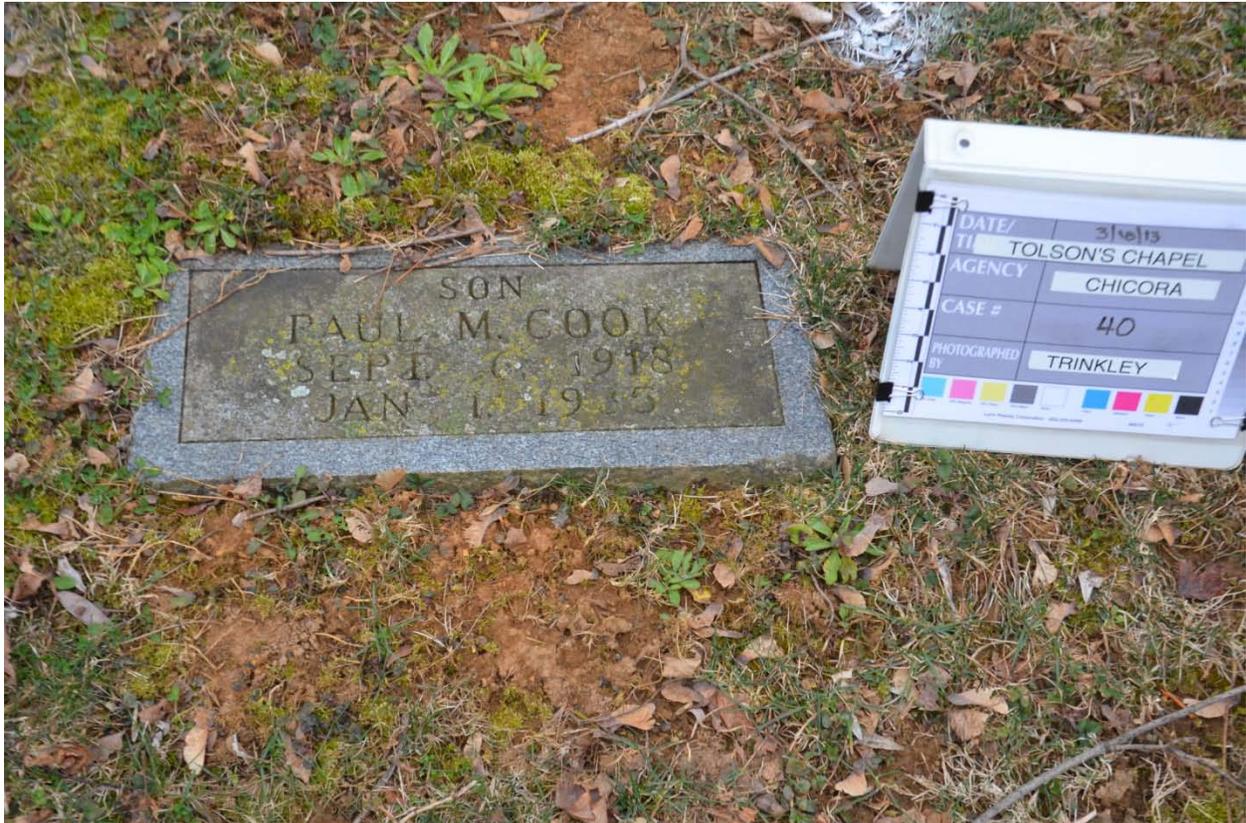
DATE/TIME	3/6/13
AGENCY	TOLSON'S CHAPEL
CASE #	40
PHOTOGRAPHED BY	TRINKLEY

Priority: 2

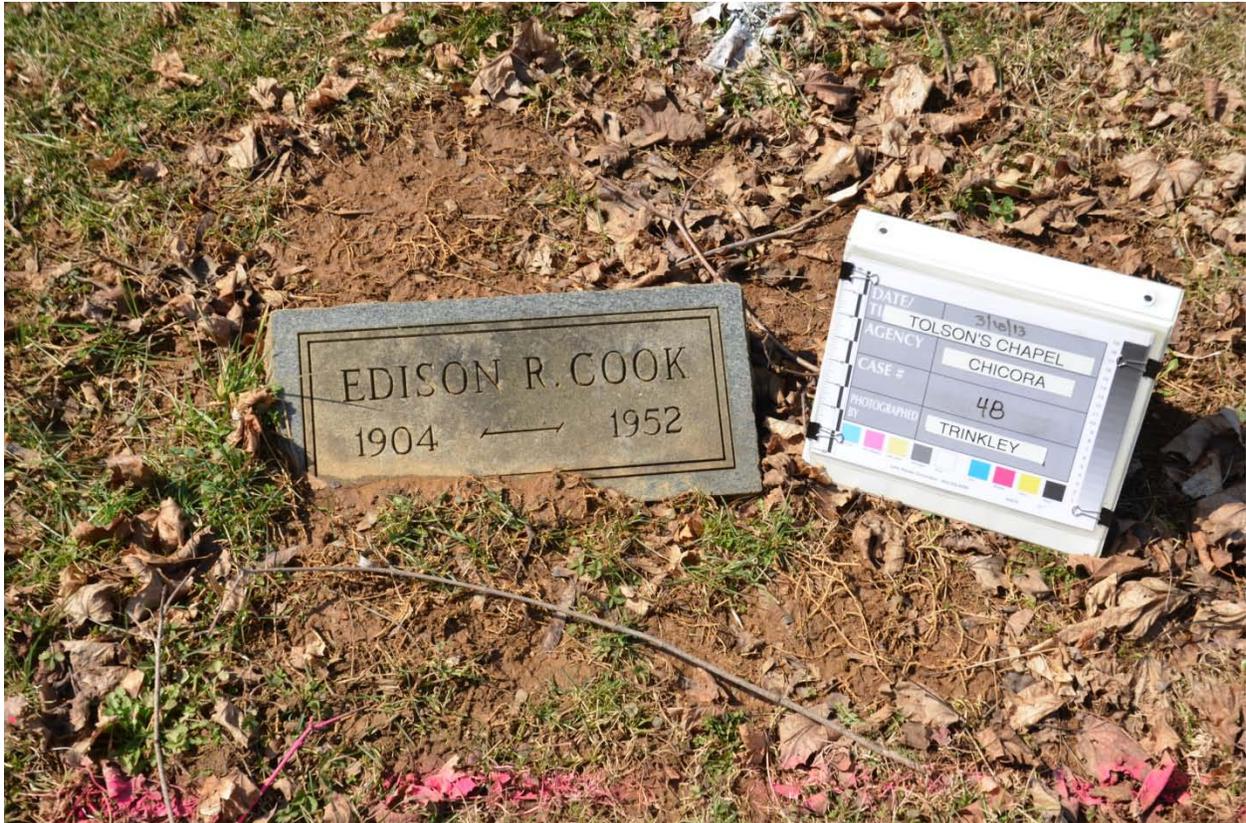
DATE/TIME	3/16/13
AGENCY	TOLSON'S CHAPEL
CASE #	CHICORA
PHOTOGRAPHER BY	4B TRINKLEY

Priority: 3
